AIRPROX REPORT No 2010151

Date/Time: 5 Oct 2010 2004Z

Position: 5421N 00218W
(13nm E Kendal)

Type: Harrier T8 MC130H

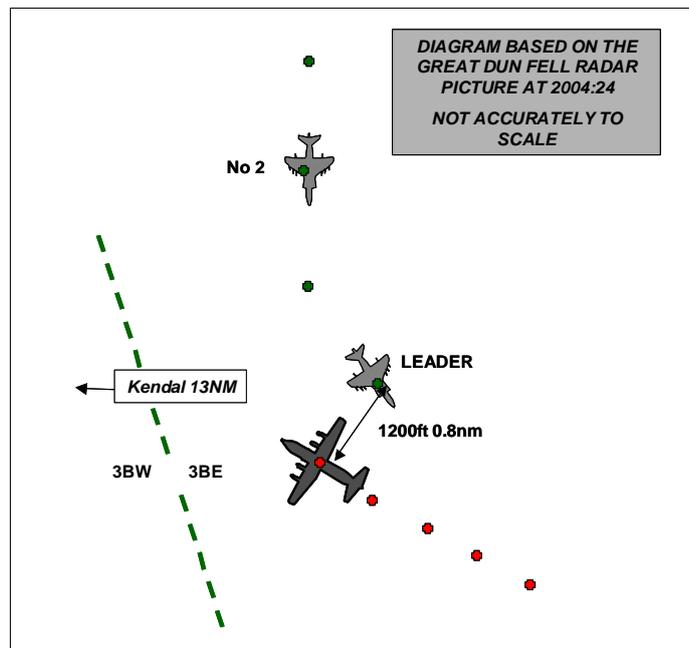
UKAB Note (3): The incident shows clearly on the recording of the Great Dun Fell radar. The Harriers are squawking 7001 with Mode C, tracking 170° towards the CPA; the C130 is also squawking 7001 with Mode C and very intermittent Mode S and tracks about 300° towards the CPA. The CPA is at 2004:25 when the C130 (at FL032) passes 0.8nm to the SW of Harrier leader who is indicating FL020 in a level break to the left.
