AIRPROX REPORT No 2010152

Date/Time: 6 Oct 2010 1129Z

Position: 5302N 00029W (O/H RW26
Cranwell - elev 218ft)

Airspace: ATZ (Class: G)

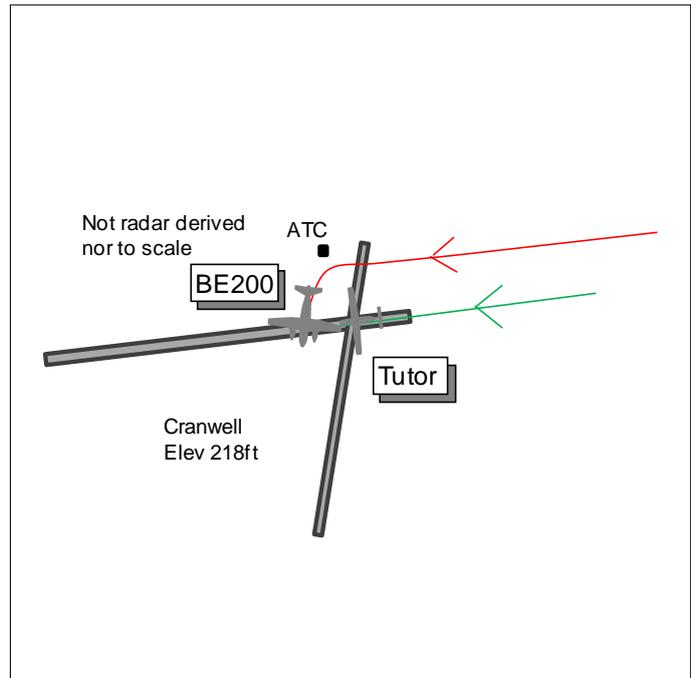
Cause: The BE200 crew elected to turn downwind early and flew into conflict with Tutor(A), of which they had lost sight.

Degree of Risk: C.
