AIRPROX REPORT No 2010163

Date/Time: 13 Oct 2010 1036Z

Position: 5750N 00313W (3nm
Final Approach RW23 at
Lossiemouth - elev 41ft)

Type: Tornado GR4 SAAB Gripen x2

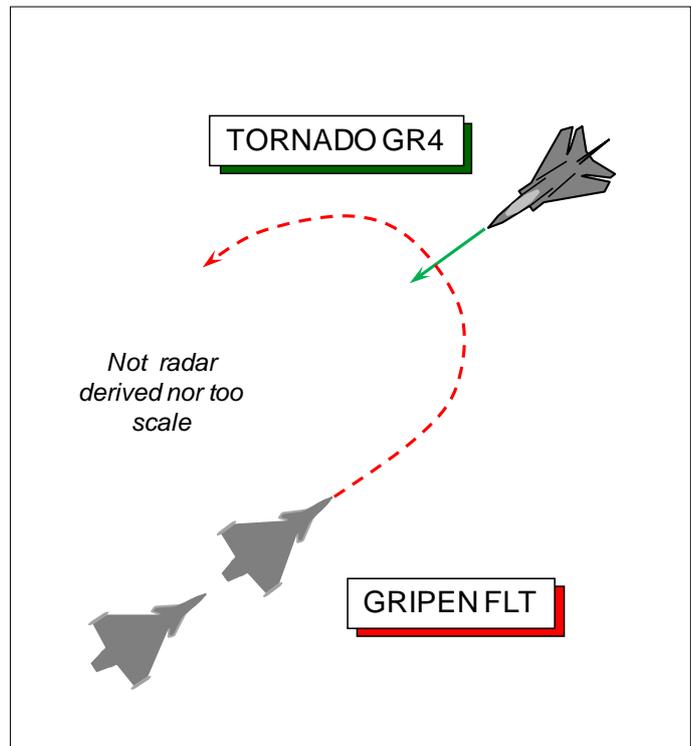
Heading 224° at 200kt, they were descending wings level on the procedure through 900ft QFE (1000mb), in IMC, when they entered a break in the clouds about 4nm from the threshold of RW23. Simultaneously, both crew members saw a grey Gripen ac pass from L to R across their nose about 200m ahead at the same height in a banked turn away from them. As they descended below the cloud base the Gripen was seen on their starboard side maintaining height, in formation with a second Gripen that had not previously been seen by either crew member. Minimum horizontal separation was 200m, but as their Tornado descended the Gripen remained level, thereby resolving the confliction before avoiding action could be taken. They reported the close proximity of the Gripen ac to TALKDOWN and continued with the SRA, landing without further incident. At no stage were the positions of the Gripen ac passed to them by ATC. Their Ground Mapping Radar was being used to locate the RW threshold, so the Gripen was not detected before being sighted. He assessed the Risk as 'high'.

Based upon the reported events, the CPA occurred when the GR4 was approaching 3nm from touchdown, with the GR4 crew gaining visual contact with both Gripens at about 2½nm from touchdown as they broke through the cloud-base.

- None of this was visible to the ADC from the Control Tower except on the ATM. The GR4 was not seen by the Gripen pilots before one of them crossed ahead belly up to the GR4, 200m ahead at the closest point the GR4 pilot reports. Considering all of the factors, the Board concluded unanimously that earlier intervention could have forestalled the Airprox and that the root Cause was that visual circuits were permitted in unsuitable weather conditions.
