AIRPROX REPORT No 2011022

Date/Time: 28 Mar 2011 1229Z

Position: 5152N 00058W (1nm NW WCO)

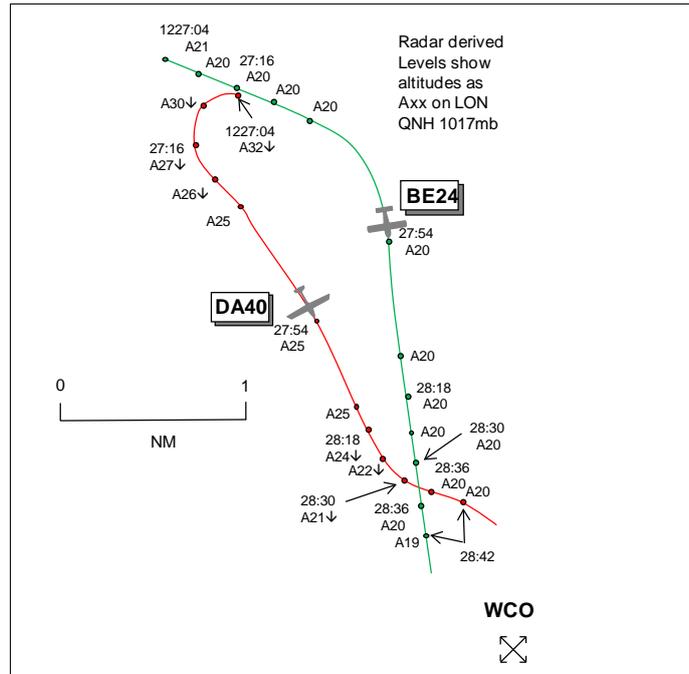
At 1227:04 the radar recording shows 3 ac operating in close proximity in the vicinity of Westcott, with the SSR labels overlapping and garbling. An expanded radar picture showed the BE24 indicating altitude 2100ft on a SE'ly track. The DA40 was indicating altitude 3200ft in a L turn, passing through a W'ly track. The third ac was tracking N indicating altitude 3000ft.

At 1227:16 the radar recording shows both ac established on a SE'ly track with the DA40 positioned 0.4nm to the SW of the BE24. The BE24 was indicating altitude 2000ft and the DA40 was indicating altitude 2700ft in a descent.

About 1min later at 1228:18 the radar recording shows the BE24 had turned R onto a S'ly track, indicating altitude 2000ft and converging with the DA40, which was tracking SE and indicating altitude 2400ft in the descent. The DA40 was ahead and in the BE24's 2 o'clock position at a range of 0.3nm.

By 1228:30 the radar recording shows the 2 ac converging on steady tracks with the BE24 indicating altitude 2000ft and the DA40 indicating altitude 2100ft. The DA40 was slightly ahead and in the BE24 aircraft's 2 o'clock position at a range of 0.1nm.

[UKAB Note (1): The CPA occurs before the next sweep which at 1228:36 shows the ac having crossed, the BE24 at 2000ft 0.1nm SW of the DA40 which is indicating 2000ft. It is estimated that the ac crossed with no horizontal separation and <100ft vertical separation.]

At 1228:42, the radar recording shows that the 2 ac tracks diverging, with the DA40 indicating altitude 1900ft and the BE24 indicating altitude 2000ft.
