## AIRPROX REPORT No 2011031

Date/Time: 9 Apr 2011 1612Z (Saturday)

Position: 5050N 00019W  
(Shoreham DW RW 20 -  
elev 7ft)

Airspace: Shoreham ATZ (Class: G)

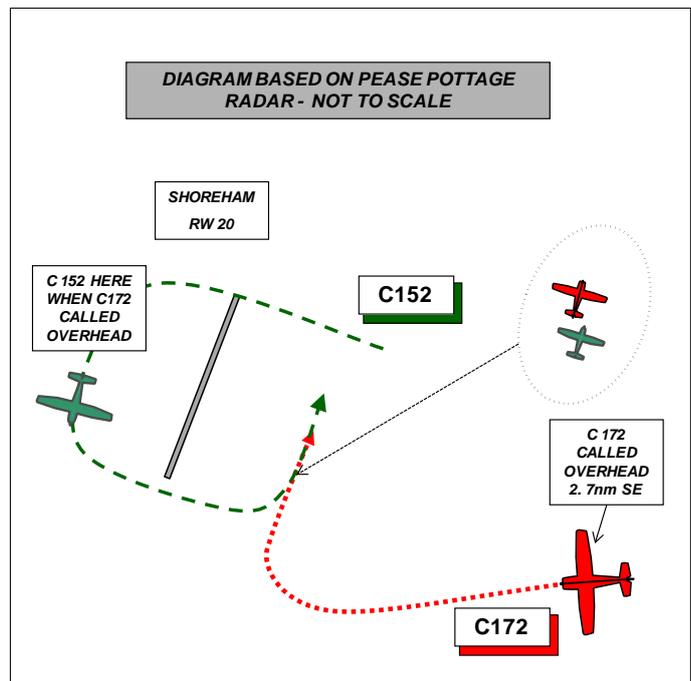
At 1611:46 radar recording shows the C172, 1.4nm SE of the airfield in a right turn at FL014 (Alt 1643ft), towards the beginning of the downwind leg with the primary contact in the crosswind position, tracking E with the ac 1nm apart and converging; the radar return on the primary contact is then lost.

The controller's workload was high and in order to ensure that traffic was sequenced appropriately into the busy traffic pattern, he instructed both pilots to join overhead. The radar recording shows that when the C152 reported overhead, the C172 was 4.5nm E of the airfield. The overhead call from the C172 pilot was made when the aircraft was 2.7nm SE of the airfield, approaching the ATZ boundary. The C172 was then seen to route directly to the downwind position.

UKAB Note (1): Although the C172 shows on the radar recording (as outlined above in the ATSI report), the primary response believed to be the C152 had disappeared before the CPA. The separation could not therefore, be determined.

Cause: The C172 pilot did not comply with the ROA or ATC instructions and gave incorrect position reports, flying into conflict with the C152 which he did not see.
