## AIRPROX REPORT No 2011035

Date/Time: 17 Apr 2011 1500Z (Sunday)

Position: 5141N 00202W (1nm  
NE Kemble - elev 433ft)

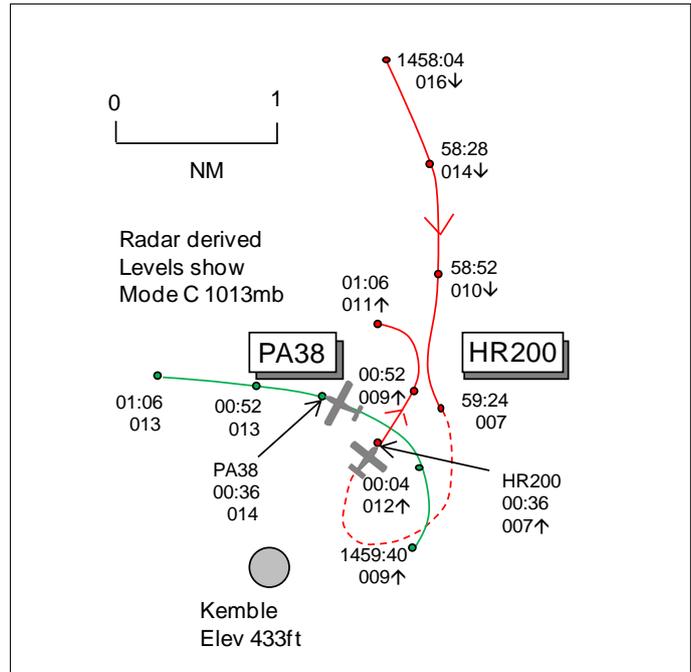
Cause: The Robin HR200 pilot joined for RW26 when RW08 was in use, and flew into conflict with the PA38.
