AIRPROX REPORT No 2011046

Date/Time: 21 May 2011 1447Z (Saturday)

Position: 5114N 00058W (1nm W
Odiham - elev 405ft)

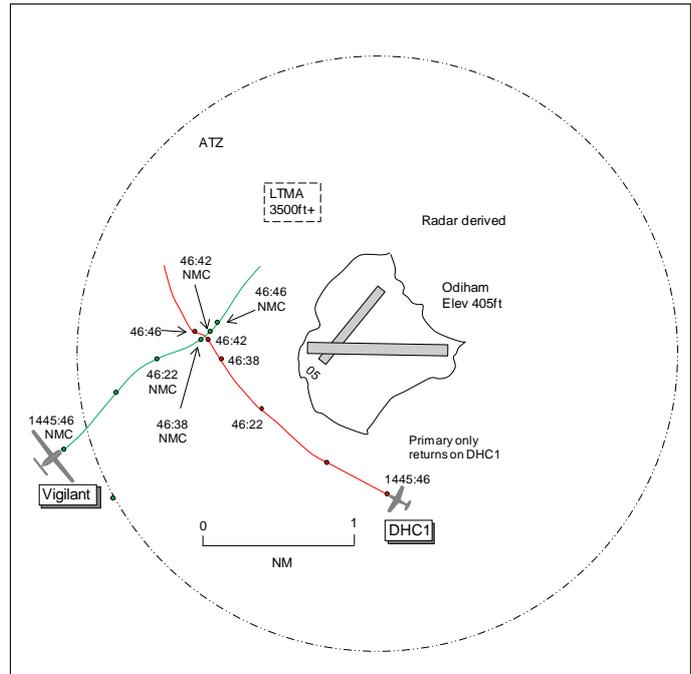
UKAB Note (3): The Heathrow radar recording at 1445:46 shows the Vigilant 2.2nm WSW of Odiham tracking 050° squawking 3647 NMC. At the same time a primary only return is seen, believed to be the DHC1, 0.9nm S of Odiham tracking 305°. The Vigilant then enters the ATZ on a steady track with the DHC1 converging from its 2 o'clock position. At 1446:22 the Vigilant is seen to have turned R approximately 20° whilst the DHC1 converges from its 0130 position range 0.75nm whilst crossing the extended C/L RW 05/23 onto a crosswind leg. Sixteen seconds later, 1446:38, the Vigilant is seen to have turned L onto a downwind track and is about to pass through the DHC1's 12 o'clock range 0.2nm. The next sweep at 1446:42 shows the DHC1 passing <0.1nm behind the Vigilant and turning sharply L before regaining a NW'ly track.

Cause: The DHC1 pilot flew unreasonably close to the Vigilant, causing its pilot concern.
