## AIRPROX REPORT No 2011057

Date/Time: 4 Jun 2011 1035Z (Saturday)

Position: 5545N 00213W (10nm S of ST ABBS VOR)

Airspace: Scottish FIR (Class: C)

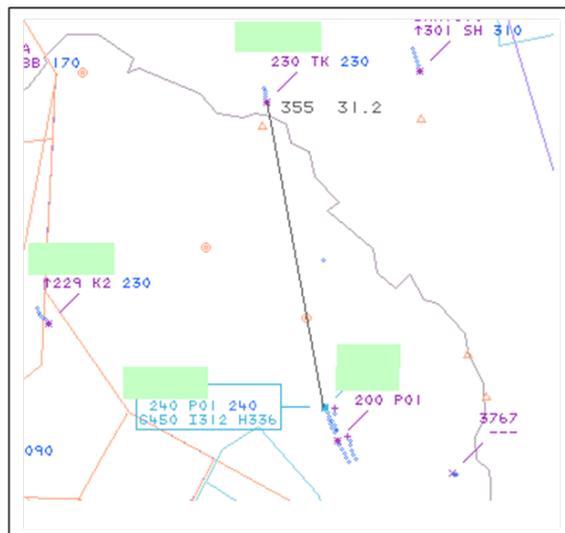
(PC MRT 1032:27)

The TAY SC requested, "*Co-ordination against the [BE9L C/S] then, not above 2 3 and you're not below 2 4 is that correct?*" The Scottish Military controller read back the co-ordination request and the conversation ended with the TAY SC stating, "*that's co-ordinated*". At 1028:40, TAY SC passed TI to the BE9L pilots, "*traffic information about 4 or 5 minutes you may see ... an American fighter and a D C 10 they'll be a thousand feet above you.*" The KC-10 and F-15 (A) formation was now overhead Newcastle and 75nm ahead of the BE9L. The formation was now maintaining FL240. The BE9L crew asked if the traffic would be on the aircraft's left-hand side, to which the controller replied, "*no ... they're in your 12 o'clock at the moment...its reciprocal*". Scottish (Mil) telephoned the TAY Sector at 1032:29 and requested the TAY SC identify another two F-15s, "[F-15 (B) flight C/S] *southeast of the [KC-10 and F-15 (A) formation C/S]*". F-15 (B) flight had now decreased its distance behind the KC-10 and F-15 (A) formation to 3.4nm. The BE9L was 31nm N of the KC-10 and F-15 (A) formation.

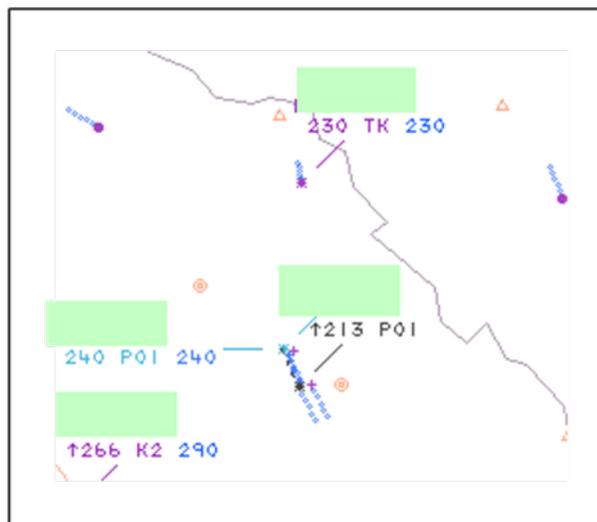
(PC MRT 1034:10)

At 1033:52 the Mode C of F-15 (B) flight leader indicated that the transponding ac had commenced a climb from FL200 and was now passing FL203; at 1034:08 it was indicating Mode C of FL213, climbing, STCA then activated between F-15 (B) flight and the KC-10 and F-15 (A) formation ahead.

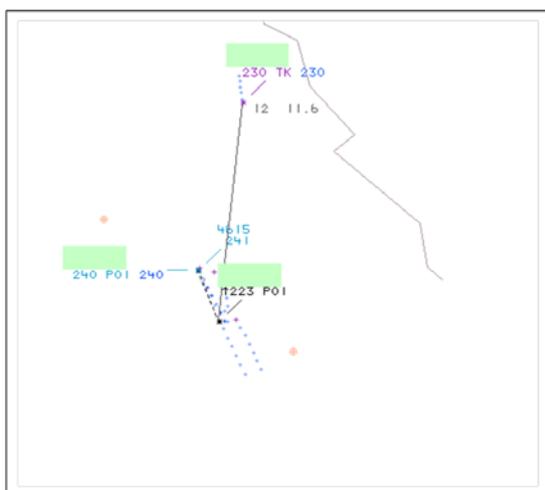
(PC MRT 1034:25)

At 1034:25 the Mode C of F-15 (B) flight indicated that they were still climbing and passing through FL223. They were in the BE9L’s 1 o’clock range 11.6nm on a track to pass down the BE9L’s right-hand side.

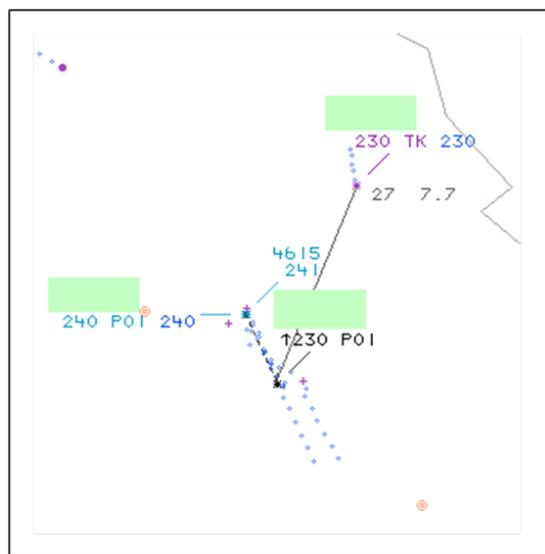
(PC MRT 1034:49)

At 1034:49, F-15 (B) flight leader’s Mode C indicated the ac were at the same level as the BE9L, still in the BE9L’s 1 o’clock, range 7.7nm. The aircraft were about 45nm N of Newcastle at FL230 in Class C controlled airspace.
