## AIRPROX REPORT No 2011120

Date/Time: 7 Sep 2011 1521Z

Position: 5006N 00508W (5nm E of Culdrose - Helford River)

Type: Merlin HM Mk1 Hawk T Mk1

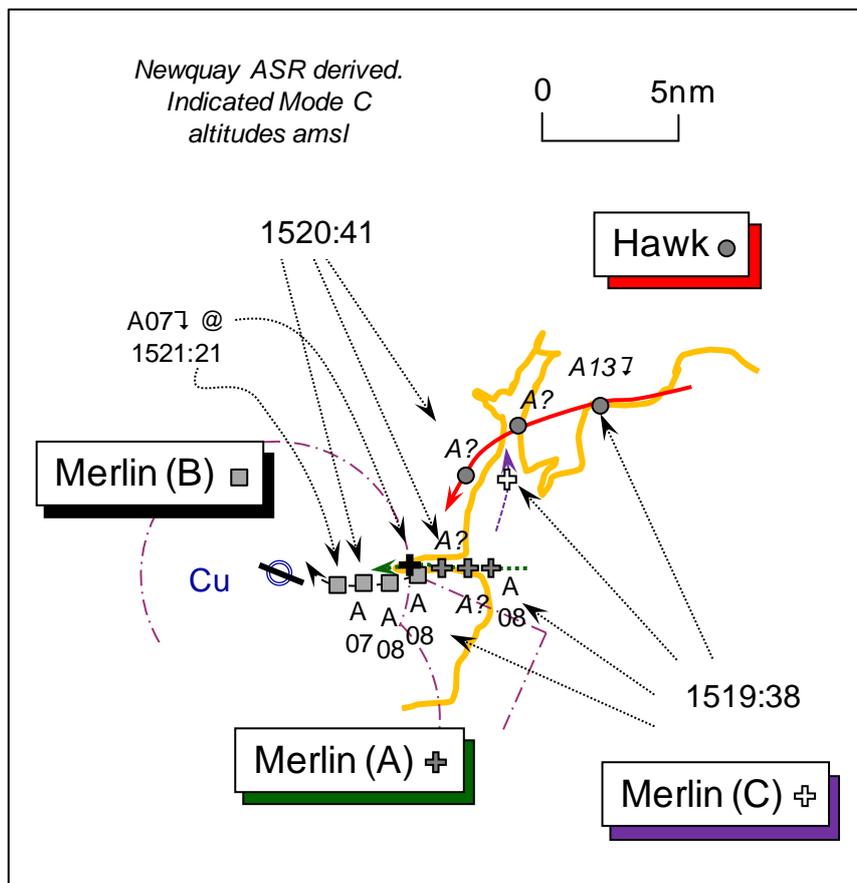
UKAB Note (2): A copy of the Newquay Cornwall Airport ASR recording was helpfully provided for the investigation of this Airprox; however, the incident is not captured at the CPA. The Hawk is shown approaching Culdrose from the NE descending through 1300ft passing to the N of Merlin (C), which is operating between Pendennis Point and Falmouth at 700-800ft ALT. However, the Hawk's contact fades just after 1520:41, 3nm N of Merlin (A) before the Hawk arrives in the vicinity of the Helford River. Both Merlin (A) and the preceding Merlin (B) are shown inbound along the S bank of Helford River between 700-800ft ALT. Merlin (A) is shown at the reported Airprox location 5nm E of the A/D at 1521:21, the helicopter's Mode C indicating a descent through 700ft ALT. Thereafter no Mode C is shown and perhaps indicative of the pilot's reported descent. Merlin (A)'s Mode C is next shown at 800ft ALT climbing and then levelling at 900ft ALT about 3nm E of the A/D.
