## AIRPROX REPORT No 2011144

Date/Time: 18 Oct 2011 1324Z

Position: 5047N 00155W ~2nm  
W of Bournemouth  
Airport - elev 38ft)

Airspace: Bournemouth ATZ/CTR (Class: D)

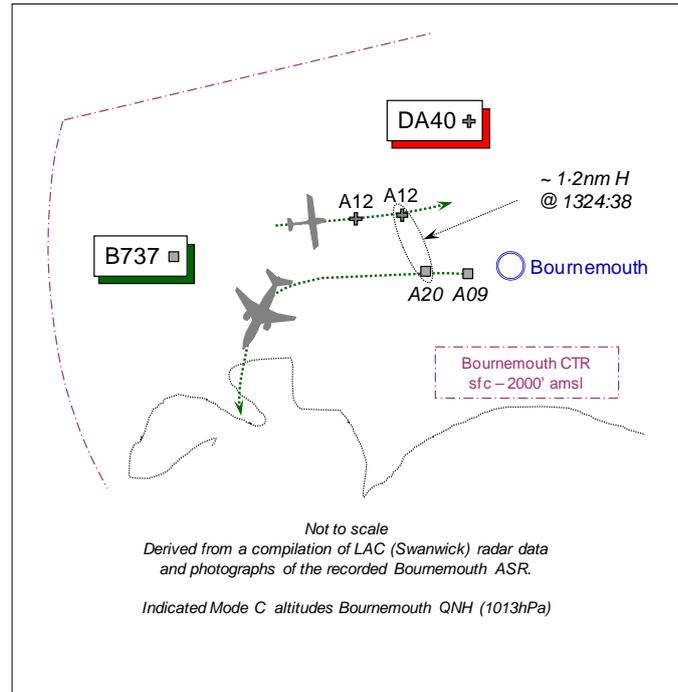
1700ft V/1.25nm H      NK

See ATSI report

Approximately 1½ minutes later, at 1324:30, the B737 was transferred to the APP frequency. The Bournemouth ASR radar photograph shows that, at the time, the subject ac had not passed abeam each other. The B737, which was 2nm W of the airport, had turned R on its noise abatement procedure and was climbing through 1700ft. The DA40 was 1.5nm NW at 1100ft, tracking ESE. The radar photograph, timed at 1324:38, shows the two ac were passing abeam each other 1.2nm apart. The B737 was passing 2000ft and the DA40, which had made a L turn to track ENE, was at an altitude of 1200ft. The cct height at Bournemouth is 1200ft QFE (aerodrome elevation 38ft).

The separation evinced by the Bournemouth radar photographs, shows that the two ac passed about 1.2nm apart at the closest point. The B737 crew's first sighting of the DA40 was at a range of 2nm, with the latter's pilot sighting the B737 earlier as it took-off, clearly in his field of view. Thus the DA40 pilot was always able to take robust avoiding action if need be, which convinced the Board that no Risk of a collision had existed in these circumstances.
