AIRPROX REPORT No 2011005

Date/Time: 28 Jan 2011 1049Z

Position: 5310N 00100W
(5nm NW Syerston)

Type: Grob Tutor T Mk1 C172

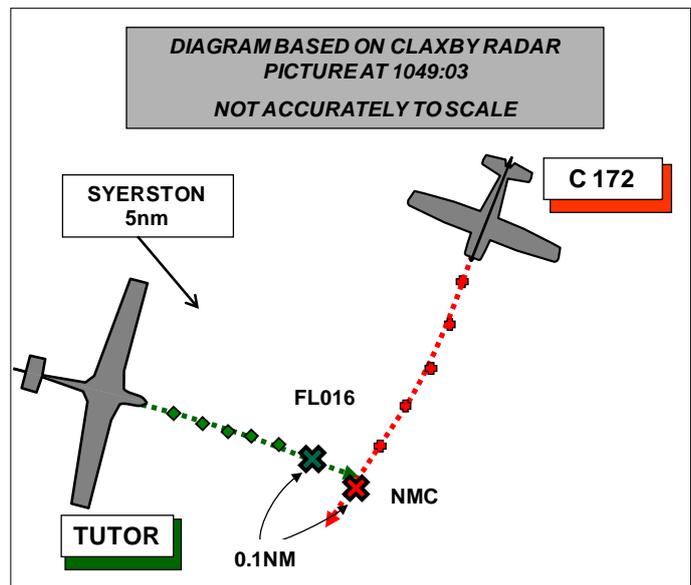
UKAB Note (1): The recording of the Claxby radar shows the incident. In the lead up to the CPA the Tutor changes squawk to 7000 at 1048:32 in the climb through FL014 to level briefly at FL016 at 1048:54 while tracking 100° towards the C172. The C172 is squawking 3603 but does not display any Mode C data as it tracks initially 195° before turning right onto 210°. It passes from left to right, on a line of constant bearing, 0.2nm (185m) ahead of and above, the Tutor which is still at FL016. Assuming that the C172 was at 2000ft amsl, as the pilot reported, the vertical separation would have been 350ft.

Cause: The C172 flew close enough to cause the Tutor pilots concern.

Risk: C.
