AIRPROX REPORT No 2011010

<u>Date/Time</u>: 8 Feb 2011 1048Z Position: 5140N 00056W

<u>Airspace:</u> Lon FIR (<u>Class</u>: G)

Type: Puma C172

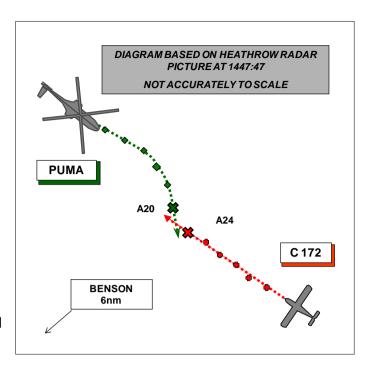
400ft V/0 H

At 1047:35 the Puma commenced a right turn putting it on a conflicting flightpath with the C172. At that point, the C172 was 0.7nm SE of the Puma and was indicating 300ft below it.

UKAB Note (1): The recording of the Heathrow radar shows the incident. The Puma squawking 3620 with Mode C approaches the CPA tracking about 170° at an alt of 2000ft as the C172 tracks about 330° towards it from its 1 o'clock at an alt of 2400ft. The C172 passes 400ft above the Puma at 1047:47.

<u>Cause</u>: A late sighting by the Puma crew.

Degree of Risk: C.
