AIRPROX REPORT No 2011014

Date/Time: 24 Feb 2011 1100Z

Position: 5413N 00143W (8nm SW by W of Leeming - elev 132ft)

Airspace: Vale of York AIAA (Class: G)

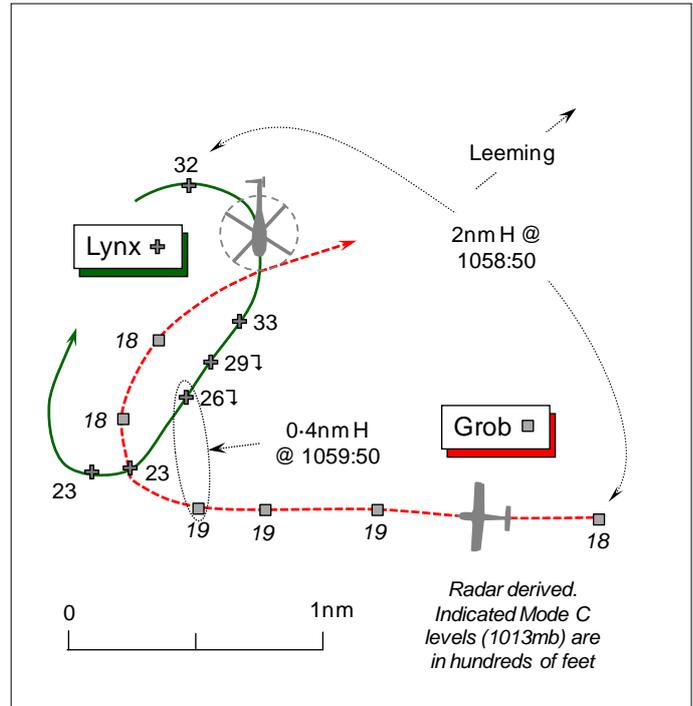
At 1059:18 the Lynx rolled out of the right-turn to track south-west, at which point 0.9nm lateral separation exists. At 1059:33 the Lynx has commenced a 2000ft/min descent, with 0.6nm lateral separation extant. At 1059:48 the Tutor appears to have made a relatively rapid manoeuvre to the NW, reducing the lateral separation between it and the Lynx to 0.2nm, with the Lynx now descending through 2400ft.

[UKAB Note (2): The Grob Tutor passed beneath the Lynx, in between sweeps, moments after 1059:50, with 700ft separation evident on Mode C before the 'merge' and 500ft afterwards as the Grob turns away to the NE.]
