## AIRPROX REPORT No 2011078

Date/Time: 12 Jul 2011 2148Z NIGHT

Position: 5230N 00001W (9nm  
NNE of Wyton)

Type: VC10 Tornado GR4

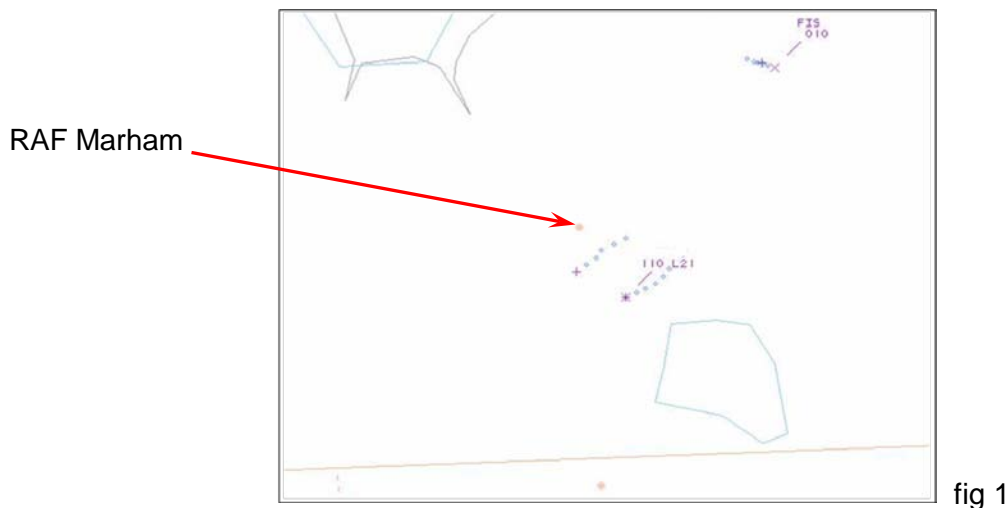
At 2144:42 LJAO EAST passed TI to what they believed to be Tornado (A), stating, "*traffic believed to be your number 1 west 1 mile tracking southwest no height information.*" Given this TI and subsequent events, LJAO EAST believed that Tornado (A) was the south-easterly of the two ac and the ac that had retained the SSR Mode 3A. In reality, as depicted in fig 1 below, Tornado (A) was

the north-westerly PSR-only contact S of Marham, whilst Tornado (B) was the combined (SSR & PSR) contact SE of Marham. The TI issued was acknowledged by the crew of Tornado (A).
