AIRPROX REPORT No 2011079

Date/Time: 12 Jul 2011 1551Z

Position: 5231N 00045W
(12nm WSW Wittering)

Type: Tutor R44 Helicopter

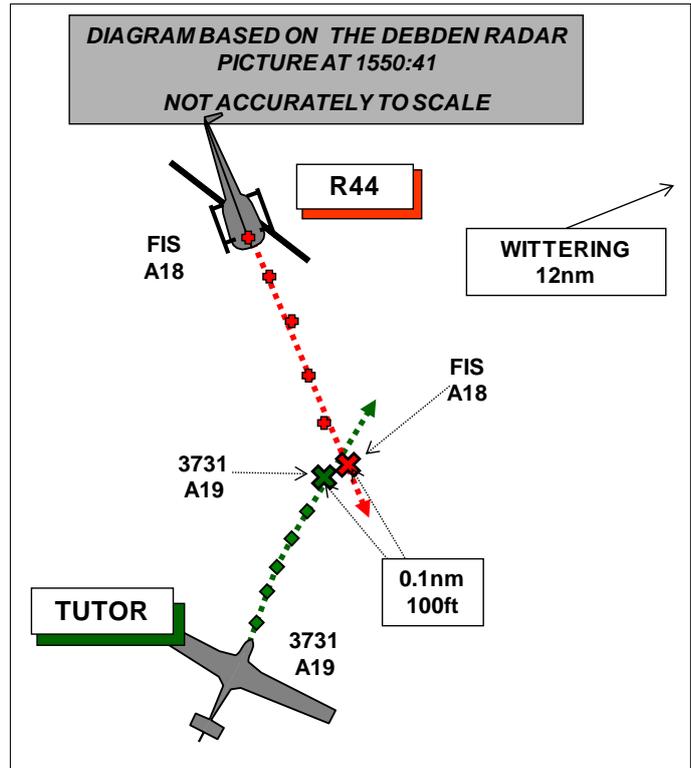
The pilot's report of being visual with the R44 is broadly coincident with the CPA, with the radar replay showing the R44 to be slightly right of the Tutor's twelve o'clock, with 0.1nm lateral and 100ft vertical separation.

UKAB Note (2). The recording of the Debden radar shows the incident clearly as depicted on the diagram above.
