## AIRPROX REPORT No 2011081

Date/Time: 3 Jul 2011 1303Z (Sunday)

Position: 5050N 00020W  
(Shoreham - elev 7ft)

Type: C152 DA40

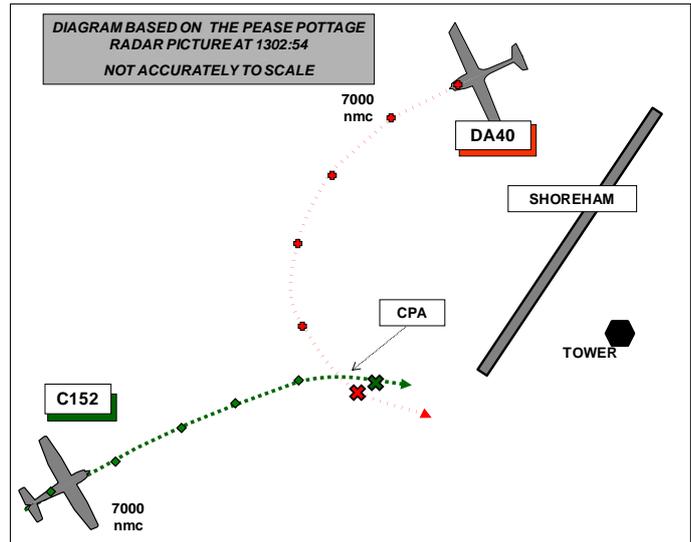
The radar recording shows the DA40 on the deadside in a L turn towards the crosswind leg with the C152 also approaching crosswind at 1302:48; neither ac is displaying Mode C and the distance between the two ac as they converge is 0.3nm.

The radar recording shows the tracks of the two ac crossed at 1302:55 and at 1302:57 shows the two ac diverging with a horizontal separation of 0.1nm and increasing with the C152 inside the DA40 on the crosswind leg.

The Airprox occurred when the DA40 did not report overhead, as instructed by ATC, and descended on the dead side without approval.

Cause: The DA40 pilot did not follow the Shoreham joining procedure and descended into conflict with the C152, which he did not see.

Degree of Risk: B.
