AIRPROX REPORT No 2011103

Date/Time: 5 Aug 2011 0951Z

Position: 5136N 00107W (1nm
SW Benson - elev 203ft)

Airspace: Benson MATZ/ (Class: G)

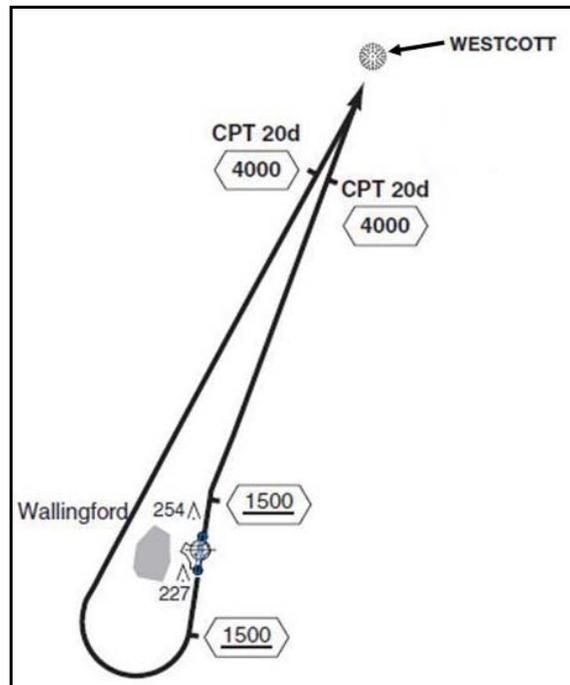
Figure 1. NE SID Benson

The NE SID RW19 procedure requires a climb on RW track (189° M), calling approach by 1000ft; on passing 1500ft (QFE) turn R to WCO, continuing climb to 4000ft (illustrated at Figure 1).
