AIRPROX REPORT No 2011109

Date/Time: 24 Aug 2011 1501Z

Position: 5425N 00138W
(9nm Final 05 Durham
Tees Valley- elev 120ft)

Airspace: Leeming MATZ (Class: G)

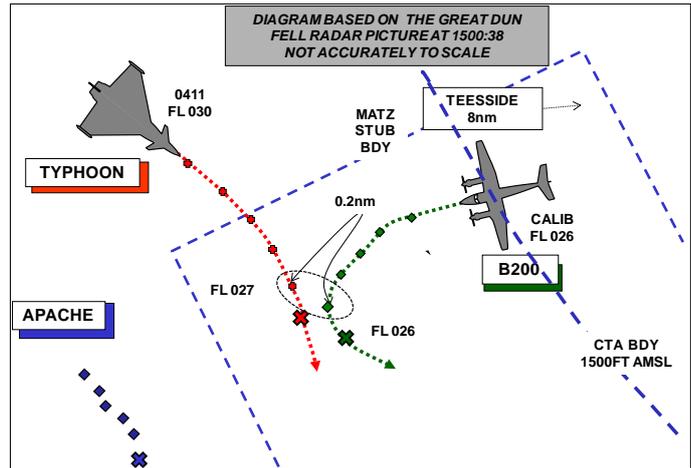
The CPA occurred at 1500:42 with the recording showing 100ft vertical and 0.1nm lateral separation. Shortly after the CPA the Typhoon pilot stated to DIR that they, "*were very close towards that calibrator, it was about a hundred metres away, one hundred and fifty metres away to the south of us...can you keep him clear please?*"

At 1500:40, radar recordings show the BE200 tracking S on base leg, 9.5nm SW of DTV, with the Typhoon on a parallel track, in its 5 o’clock at a range of 0.2nm (CPA) and 100ft above. Both ac indicated FL026 (converts to 2492ft on QNH 1009 with 1mb equal to 27ft). The BE200 pilot’s report indicated that the Typhoon was sighted at that point, ‘as BE200 turned from 240 to 190 Typhoon was sighted co-altitude in my 5 o’clock position. Left turn continued with increased bank.’

UKAB Note (1): The Great Dun Fell radar shows the incident clearly as depicted in the diagram above.
