AIRPROX REPORT No 2011111

Date/Time: 20 Aug 2011 1127Z (Saturday)

Position: 5334N 00305W
(Woodvale - elev 37ft)

Airspace: ATZ (Class: G)

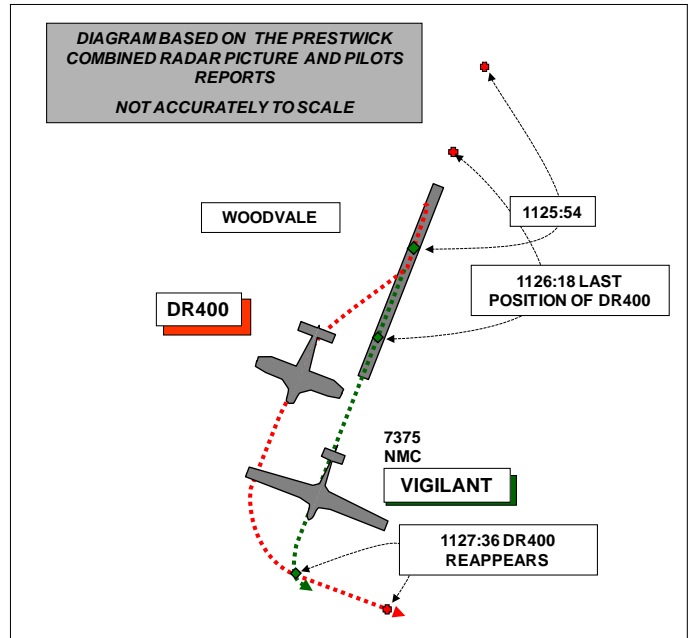
UKAB Note (1): There were irreconcilable differences in the time of this incident. All times discussed have been changed to UTC where possible. The Vigilant pilot reported the incident as taking place at 1400 and the DR400 pilot as 1230 with his flight times logged as 1235–1335. The flight times were confirmed with the pilot in a later telephone call and he confirmed that the incident had taken place towards the end of the flight. The CAA SRG Transcription Unit listened to many hours of RT tapes and the only time that there was a RT call of the DR400 (C/S) asking the Vigilant (C/S) asking if he was about to roll was at 1226:54; although the Transcription Unit believed this to be a UTC time, further investigation with the unit showed it to be BST so all the times in the ATSI report have been adjusted accordingly. The recording of the Prestwick combined system radar, commencing at 1125, shows tracks corresponding to both the Vigilant, squawking 7375, and a primary only track in the cct flying precisely the profile described by the DR400 pilot. It is thought likely therefore, that the incident occurred just after 1127UTC; at that time the non-squawking DR400 had disappeared from radar, reappearing at 1127:36 ahead of the Vigilant as shown above.

UKAB Note (2): At the time of the incident the recorded wind at Liverpool (16nm to the S) was 220° at 12kt. After the Vigilant gets airborne its radar derived groundspeed (GS) increases to 60kt but over a 1 minute period from 1127:02 it reduces to an average of 30kt before increasing again to 50kt at 1127:49. A primary return corresponding to the DR400 reappears ½nm away in the Vigilant's 3 o'clock just before the Vigilant turns crosswind behind it. Although not called on the RT or mentioned in the Vigilant pilot's report, its flight profile (although it could not be confirmed by Mode C information) would correspond with that of an EFATO drill.

Members were perplexed by the timing issues but were content that the geometry of incident was as portrayed in the diagram above and the actual time was not particularly significant. A GA Member informed the Board that integrating traffic flying at significantly differing speeds in the visual circuit can be challenging for pilots. The basic rules however, still apply and following ac must conform to the pattern being flown by those ahead regardless of the size. If they cannot conform safely, they should go-around or leave the circuit and rejoin in a more suitable position.

Cause: The DR400 pilot flew close enough to cause the Vigilant instructor concern.

Degree of Risk: C.
