AIRPROX REPORT No 2011127

Date/Time: 27 Sep 2012 1422Z

Position: 5050N 00018W (0.25nm
SW Shoreham - elev 7ft)

Airspace: Shoreham ATZ (Class: G)

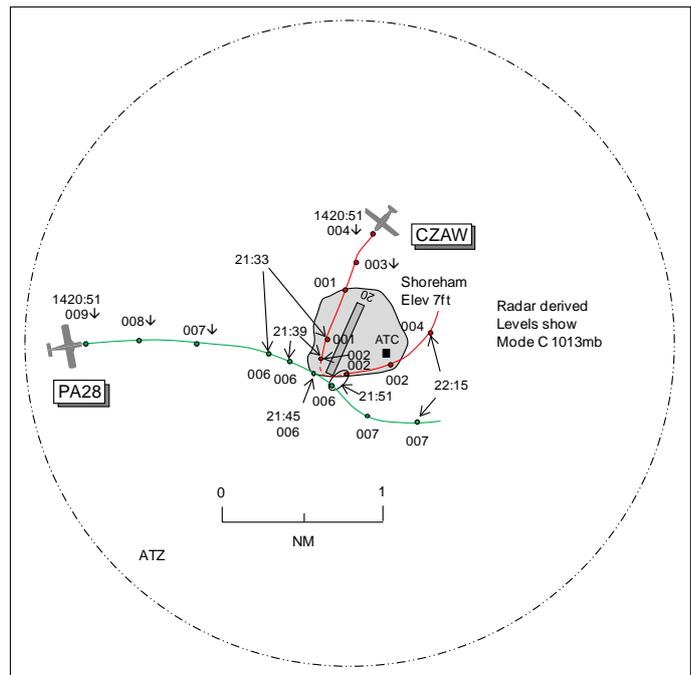
[UKAB Note (1): The sweep at 1421:39 shows the PA28 maintaining FL006 (1032ft QNH) with the SportCruiser in its 11 o’clock range 0.2nm indicating FL002, 400ft below. The next sweep 6sec later at 1421:45 shows the PA28 crossing the upwind end RW20 at FL006 with the SportCruiser having faded from radar. Six seconds later at 1421:51 the radar shows both ac again, the SportCruiser at FL002 (632ft QNH), having made a sharp L turn, and now turning through heading 080° 0.1nm NE of the PA28 which is seen to be turning R and diverging, still maintaining FL006 (1032ft QNH). The CPA occurs between 1421:39 and 1421:51, whilst the SportCruiser has faded, and it is estimated to be <0.1nm H and 400ft or less.]

The radar recordings show the SportCruiser was indicating 400ft below the PA28. The PA28 pilot’s written report indicates 300ft and the SportCruiser pilot’s report stated several hundred feet. It is likely that the controller and PA28 pilot were concerned, when the SportCruiser made a tight L turn below the PA28 into a short lower level cct. It was not clear why the SportCruiser pilot carried out this manoeuvre.

The incident is attributed to the SportCruiser going around and making a non-standard manoeuvre below the PA28, which caused the controller and PA28 pilot to be concerned about the safety and proximity of the 2 ac. The controller passed appropriate TI to the SportCruiser pilot, who in his written report indicated that he was visual with the other PA28 above, with little chance of collision.
