AIRPROX REPORT No 2011139

Date/Time: 13 Oct 2011 1127Z

Position: 5146N 00205W
(7nm N Kemble)

Type: BE200 Untraced

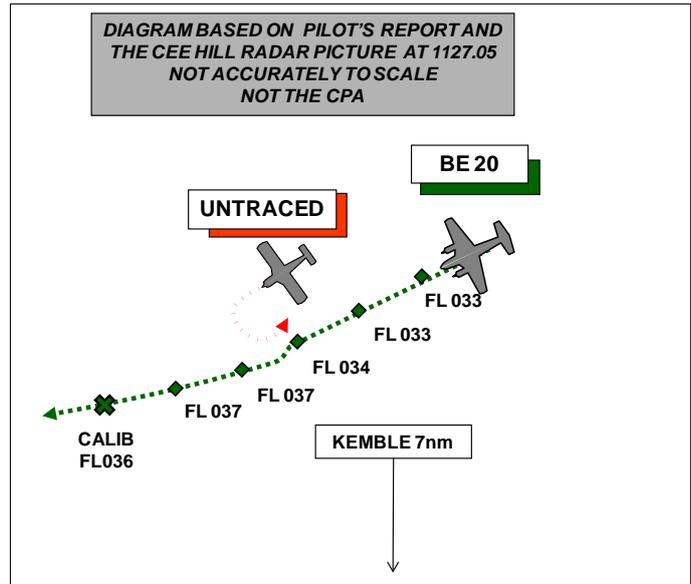
UKAB Note (1): The other ac appeared on the Clee Hill radar as an intermittent primary only contact on a similar track to the BE200 before turning. Despite extensive procedural tracing action the ac could not be identified. The CPA appeared to take place at about 1126:45 as the BE200 was squawking 'ident' (no request was apparent on the RT transcript). At that point the ac commenced a climb levelling 200ft above its cruising alt before descending again and then turning L on to the base leg. Although the radar recording appears to show a slight right hand turn commencing at 1126:53, the left hand turn reported by the pilot probably took place at about 1126:40 and was between radar sweeps; consequently it could not be seen on the recording.

Although no conflicting traffic can be seen on the radar replay, at 1126:45 the BE200 can be seen to have climbed 200ft and, at 1126:48 to have climbed a further 200ft. Based upon the BE200 HP’s description of the initial avoiding action taken by the NHP on sighting the unknown ac, this suggests that this was the point when the Airprox occurred.

While it cannot be proved conclusively, based upon the evidence it appears that the ac that was the subject of the TI passed to the BE200 by DIR, was the reported ac. In this instance the ATM related safety barrier operated effectively in that the BE200 was provided timely and accurate TI in accordance with CAP 774. Unfortunately, the lack of an operating transponder on the unknown ac prevented the operation of the additional safety barrier offered by the BE200’s TCAS, leaving ‘see and avoid’ as the remaining safety barrier. Whilst it has not been possible to determine whether the pilot of the unknown ac was able to ‘see and avoid’, the BE200 NHP was able to visually acquire the unknown ac in time to take avoiding action.
