AIRPROX REPORT No 2011147

Date/Time: 21 Oct 2011 1525Z

Position: 4910N 00216W (APR
RW09 Jersey - elev
277ft)

Airspace: Jersey ATZ (Class: D)

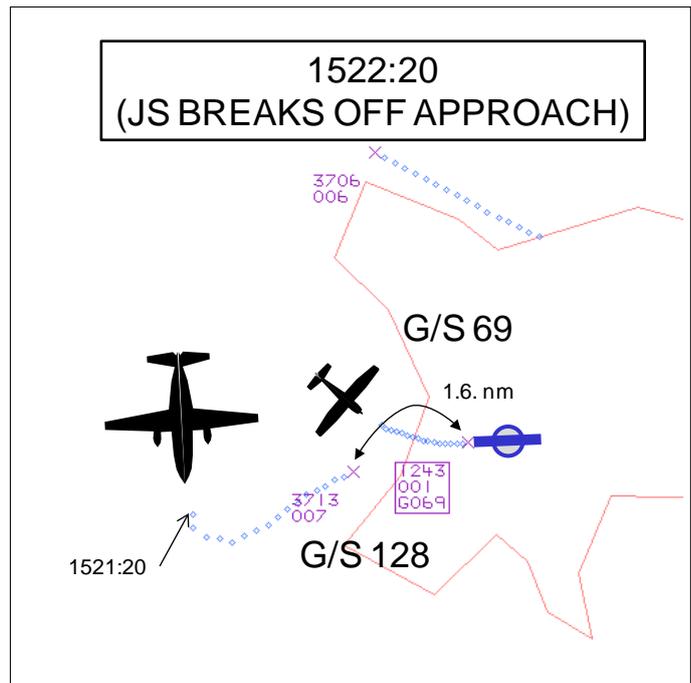
Reported Separation:

300ft V/0m H NK V/NK H

Recorded Separation:

700V / 1.6nm H

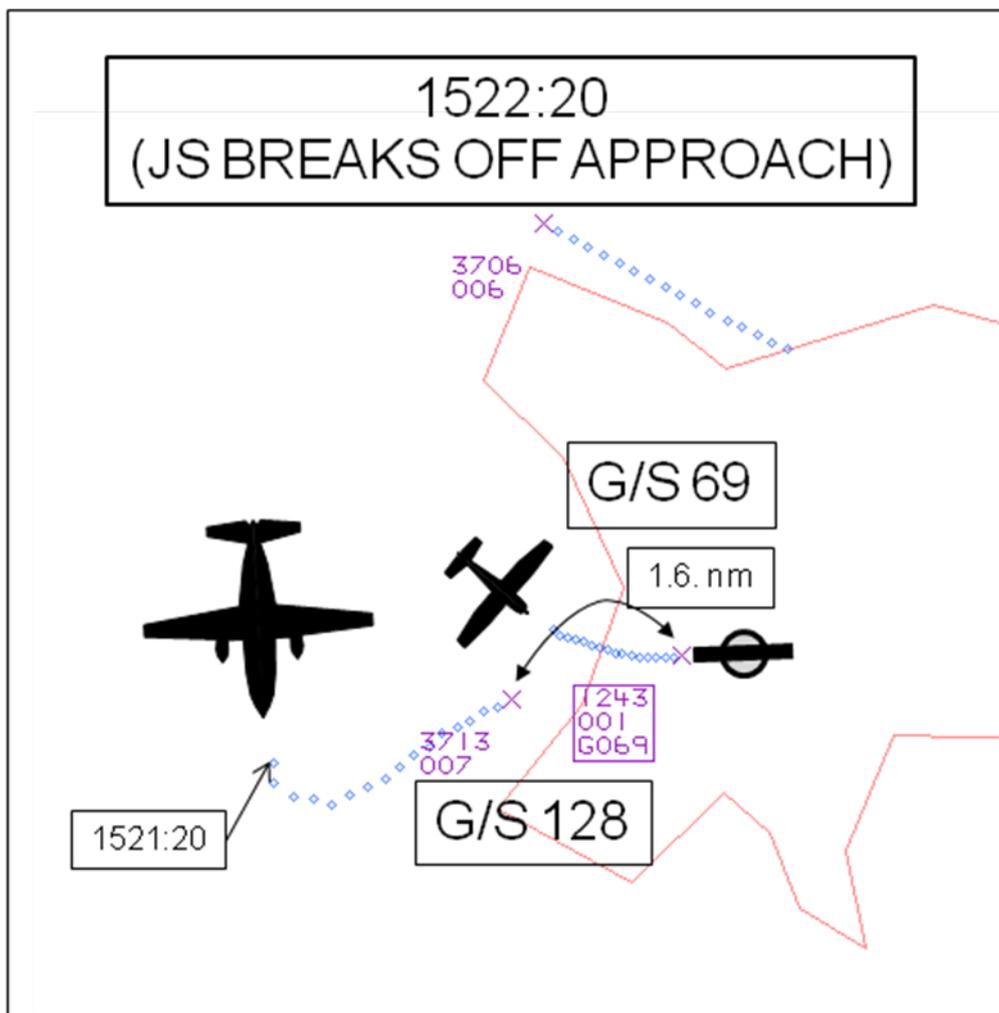
1521:10 The JS32, heading 180 degrees, was instructed to turn in towards the field, position approximately 0.5nm south of a 4nm final: C172 on an approximate 1.5nm final.

1522:02 The JS32 (approximate 2.2nm final indicating altitude 1100 feet) advised TWR they were too tight behind C172 (approximate 0.5nm final indicating altitude 600 feet) and at this point were instructed by the TWR controller to carry out a go around, at the pilot's request, into the left hand VFR circuit.

It is concluded from the investigation that this incident is attributed to the fact that the JS32 was positioned too close behind the C172 which ultimately led to the JS32 performing a go-around. The controller admitted that his perception was that C172 would hold at the North West corner of Jersey and this was exacerbated by the electronic flight strip not being present on the approach controller data display.
