## **AIRPROX REPORT No 2011150**

Date/Time: 24 Oct 2011 1212Z

Position: 5235N 00233W (13nm  
SSE Shawbury)

Airspace: Shawbury AIAA (Class: G)

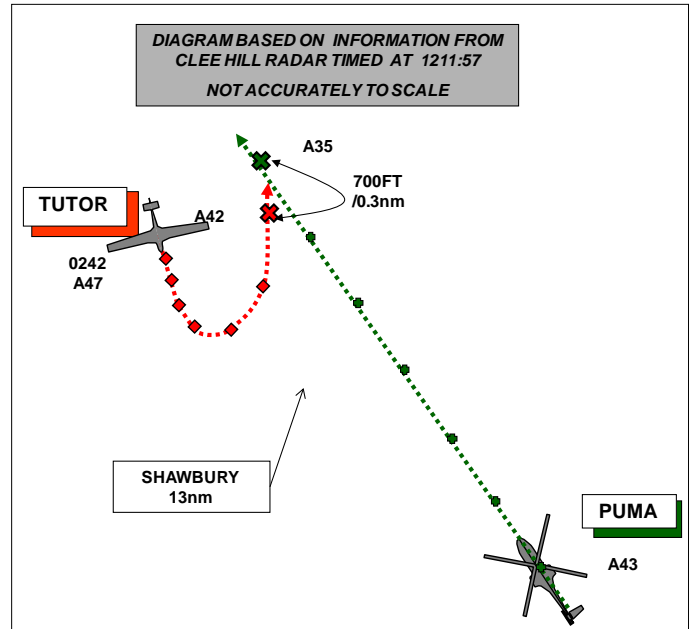
700ft V/0.3nm H

At 1211:36 RAD passed TI to the Puma on unrelated traffic and was asked to, “*say again*” by the pilot; the TI was re-stated but not acknowledged. At that point, the Tutor was 1.1nm W of the Puma, tracking SE’ly and indicating 200ft above. At 1211:45, the Tutor commenced a left turn and, at 1211:52 the Puma commenced a descent. At 1211:54, RAD passed further TI on unrelated traffic to which the Puma replied, “*standby [Puma C/S] just bear with us due to traffic.*” At that point the Tutor was 0.4nm S of the Puma, continuing its left turn through a heading of about 030°, indicating 4400ft, 700ft above the Puma. The Tutor maintained the left turn, rolling out momentarily in the Puma’s 6 o’clock, before re-commencing a left turn to the S at 1212:09. The CPA occurred at 1211:57 as the Tutor positioned 0.3 nm in the Puma’s 6 o’clock, 700ft above; the Puma indicated 3500ft at this point.

Cause: The Tutor pilot flew close enough to the Puma to cause its crew concern.

Degree of Risk: C.
