## AIRPROX REPORT No 2011163

Date/Time: 2 Dec 2011 1057Z

Position: 5151N 00057W (WCO)

Type: Merlin PA34

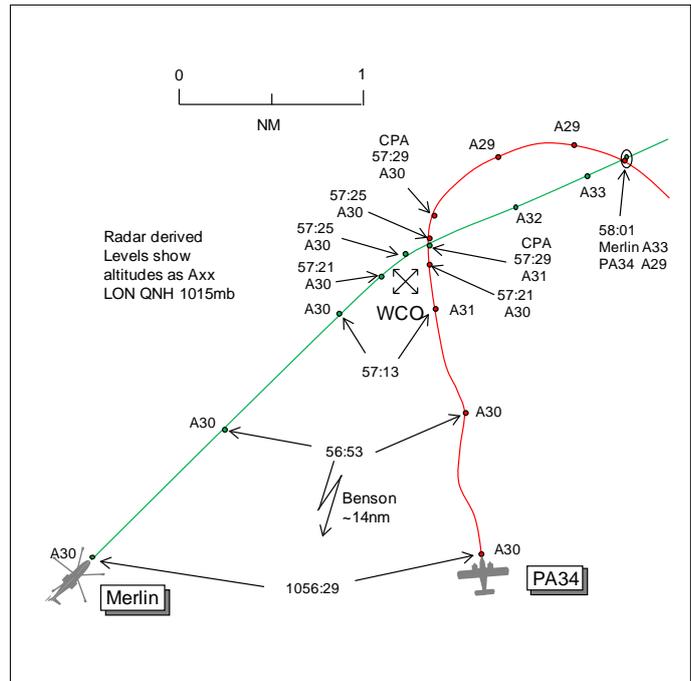
The CPA was at 1057:29 with the PA34 at 3000ft having passed ahead of and now 0.1nm from the Merlin in it's 11 o'clock showing 3100ft.

[UKAB Note (1): The next radar sweep at 1057:25 shows the PA34 crossing 0.2nm ahead of the Merlin, both ac at altitude 3000ft. Four seconds later at 1057:29 the CPA occurs, the PA34 level at 3000ft having crossed R-L ahead of the Merlin indicating 3100ft QNH, in the Merlin's 11 o'clock at a range of 0.1nm.]

The Merlin then continues on a NE'y track and the PA34 commences a R turn to re-cross the Merlin's track at 1058:01, at a position 1.4nm NE of WCO. The Merlin is indicating an altitude of 3300ft and the PA34 2900ft. The 2 ac then begin to diverge.
