## AIRPROX REPORT No 2012001

Date/Time: 4 Jan 2012 0910Z

Position: 5606N 00150W (6½nm S of NEXUS [17nm NE of ST ABBS VOR])

Airspace: Scottish FIR (Class: G)

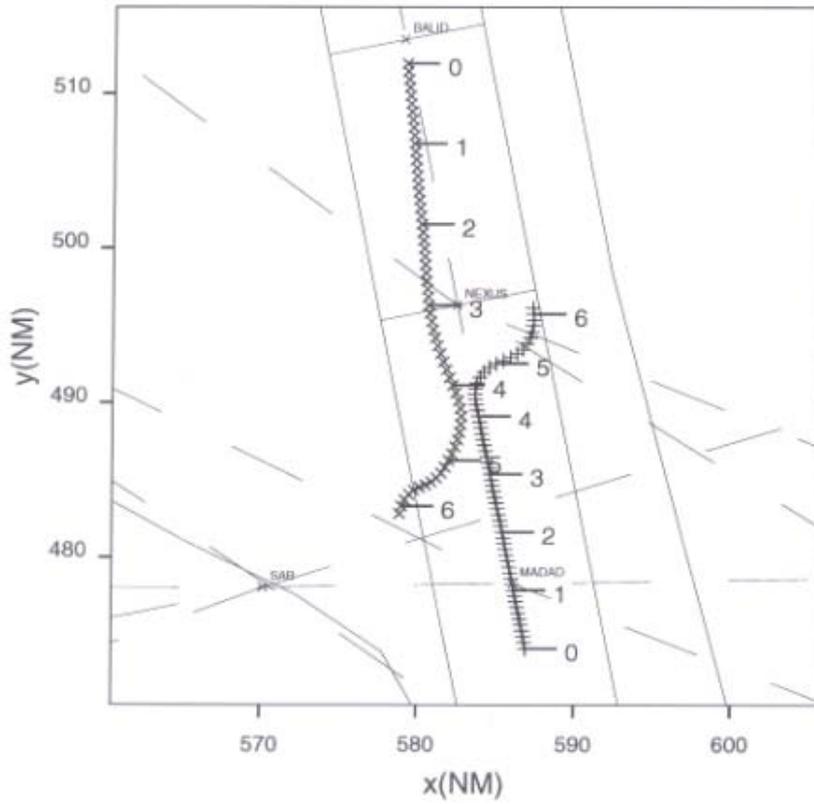
SMF data 1

The following data was produced by SMF (Separation Monitoring Function) which supports the minimum separation already assessed.

**Minimum Lateral Separation**

<i>Min. Latsep Time</i>	<i>Horizontal Sep. (NM)</i>	<i>Vertical Sep. (ft)</i>
09:10:57	1.05	1224

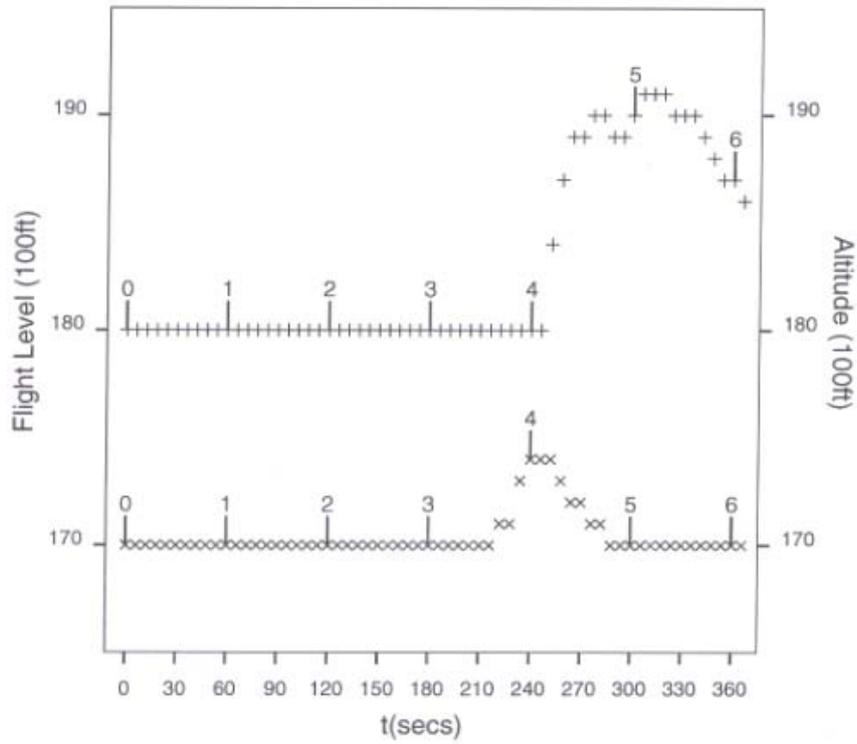
SMF data 2

**Minimum Vertical Separation**

<i>Min. Vertsep Time</i>	<i>Horizontal Sep. (NM)</i>	<i>Vertical Sep. (ft)</i>
09:10:45	2.29	581

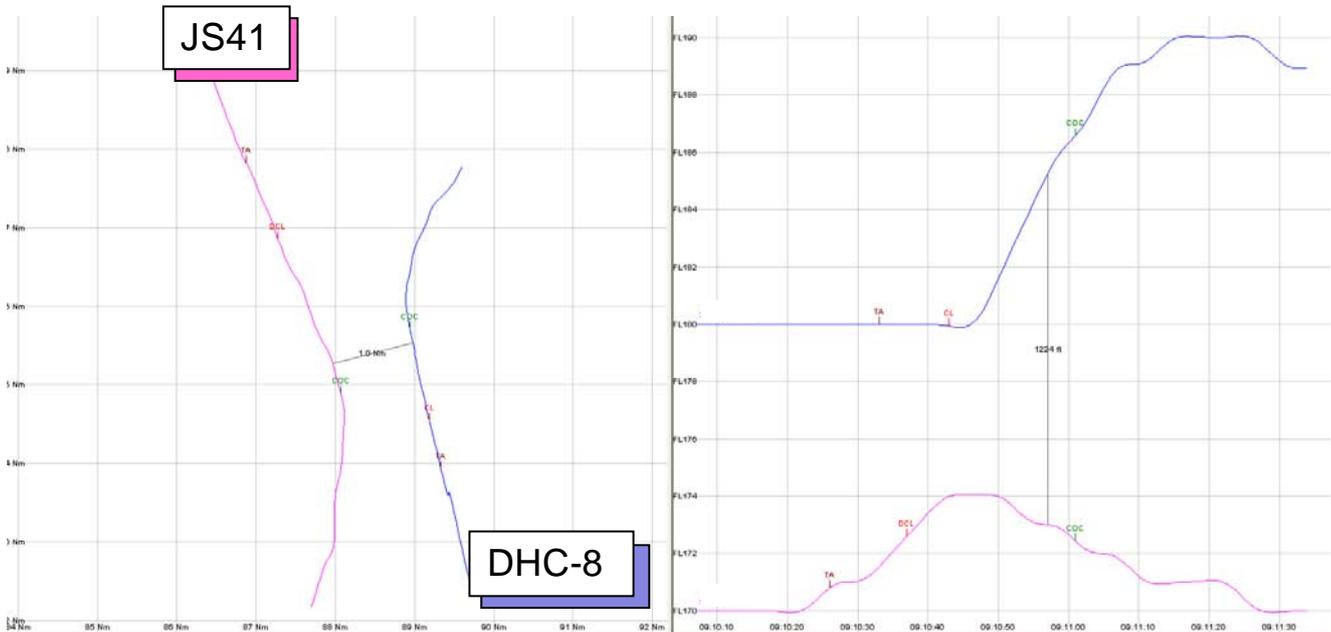
TCAS Simulation Data

This gives the closest lateral and vertical points as follows:-

Simulation of this encounter suggests that both aircraft received a traffic alert (TA); the JS41 at approximately 0910:26, followed by the DHC-8 about 7sec later. The JS41 then received the first RA at 0910:37. The RA was a *don't climb* (enunciated "Adjust vertical speed, adjust") and the ac levelled off 8sec later. The DHC-8 then received its first RA which was a *climb* ("climb, climb") at 0910:43 and started to climb 4sec later.
