AIRPROX REPORT No 2012018

Date/Time: 20 Feb 2012 1602Z

Position: 5205N 00036W (1nm FIN APP
RW21 Cranfield - elev 358ft)

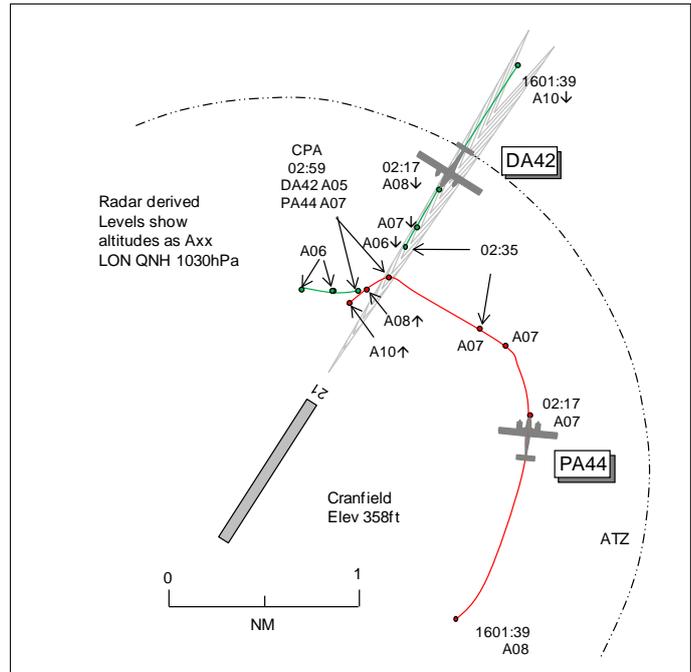
At 1602:17 the DA42 was on final 1.8nm NE of the airfield at 800ft while the PA44 was S of the DA42 by 1.3nm at 700ft.

At 1602:35 the PA44 at altitude 700ft had turned base inside the track of the DA42, which was indicating 600ft and was in its 10 o'clock position range of 0.6nm. The DA42 then fades from radar.

The radar replay shows that the PA44 flew a much smaller cct than the DA42. In addition, the DA42 was simulated asymmetric and the surface wind was reported as 23018G28kt when the DA42 was given landing clearance. The DA42 had a GS of 77kt on final compared to the 119kt GS of the PA44 on the downwind leg.

The pilot of the PA44 was told twice to position No 2 to the DA42. When the pilot turned base he could not see the DA42 but continued to final in the belief that he had become No 1. The smaller cct flown by the pilot of the PA44 in combination with the difference in GS may have led to the PA44 pilot's perception that the DA42 was further ahead than was in fact the case.
