ATSI reports that the Airprox was reported in LTC airspace when an A340 and an A320 came into conflict at FL080 approximately 14nm W of LAM.

An Airprox was reported following a loss of separation between an A340 and A320 in LTC airspace when the A340, having been instructed to continue on its present heading (065°) and climb FL150, commenced a R turn away from its assigned heading.

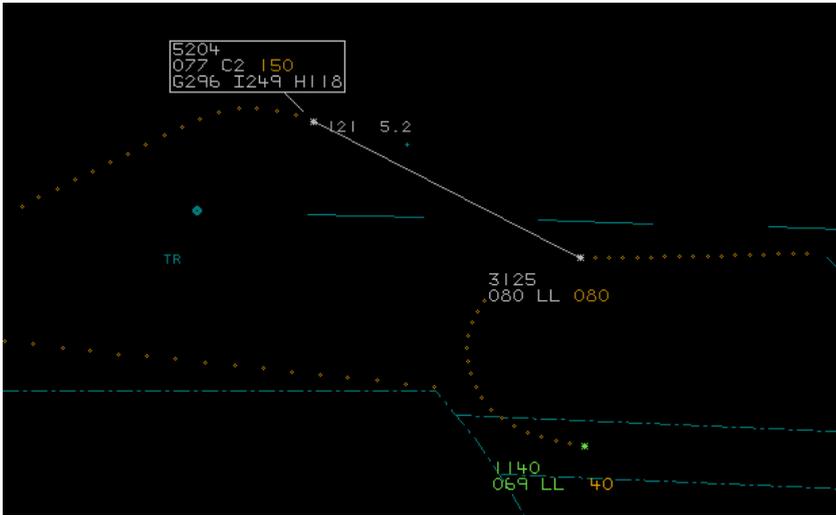
Figure 1: (Swanwick MRT) 1435:13 UTC

At 1435:00 the A340 was 30° to the R of the SID track (Mode S heading 095°) and the NE trainee instructed the A340 flight to, "...turn left twenty degrees", and after a correct read back the NE trainee transmitted, "(A340 c/s) avoiding action turn left now heading zero four zero degrees." Immediately after the read back of the heading the NE mentor assumed control of the RT and passed TI, (A340 c/s) twelve o'clock er flight level eight zero left turn immediately heading zero four five." The A340 pilot responded, "we're turning left this time (A340 c/s)." The A340 was further instructed to, "...expedite climb."

Low-Level STCA activated between the A340 and A320 at 1435:13. Separation between the 2 ac was 5.2nm/300ft (3nm or 1000ft required). See Figure 1.

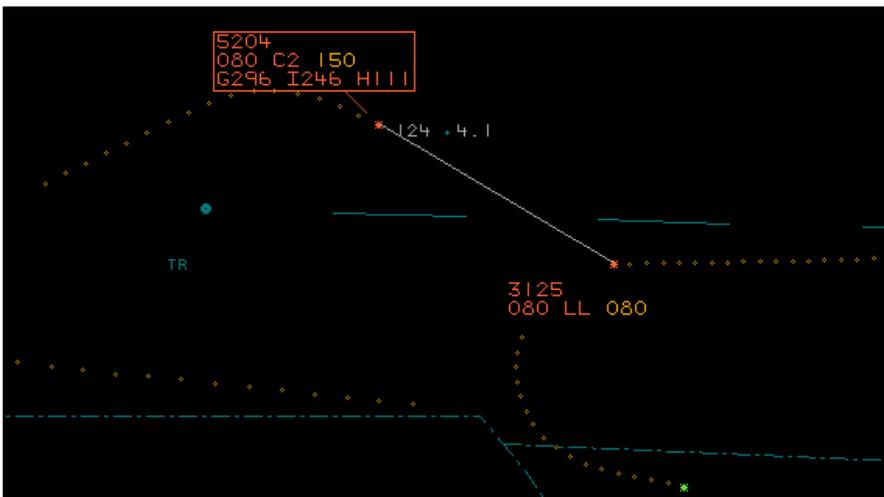
Figure 2: (Swanwick MRT) 1435:21

High Level STCA was activated at 1435:21 as the A340 passed FL080, Mode S heading 111°, 4.1nm NW of the A320. (See Figure 2). On the next update of the surveillance replay the STCA downgraded to Low Level and the A340 was observed to have turned L from a Mode S heading of 111° to 102°.

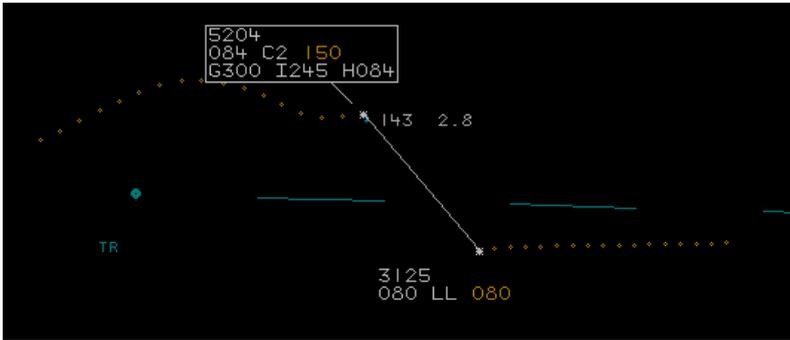
Figure 3: (Swanwick MRT) 1435:33

Separation was briefly lost at 1435:33 when the distance between the 2 ac fell to 2.8nm/400ft. (See Figure 3). At this time the A320 could be seen to be commencing its L turn and the A340 had turned L to heading 084°.

The separation requirement between the 2 ac was either 3nm or 1000ft. Separation was lost for 16sec. The minimum distance between the 2 ac was 2.6nm and 700ft. At this time the 2 ac were diverging and no risk of collision existed.

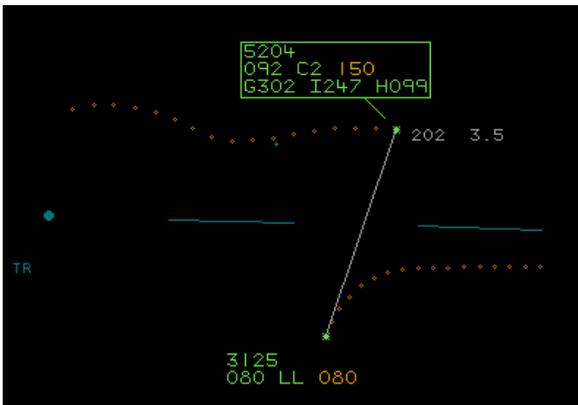
Figure 4: (Swanwick MRT) 1435:57

Separation was restored at 1435:49 when the A340 passed FL090 (2.9nm/1000ft), the A320 now firmly established in its LH turn and moving away from the A340. At this time the A340's Mode S heading reported that the A340 had turned slightly further to the R onto heading 093° then onto 099°. (See Figure 4).

At 1435:57, the NE trainee, having resumed control of the sector, informed the A340 flight, "(A340 c/s) you're turning right again turn left now heading zero four zero degrees." The pilot replied, "we're turning left zero four zero." The NE mentor again assumed control of the sector and informed the A340 crew, "...you seem to be tracking about er heading of er one hundred at the moment." The pilot replied, "we're turning through zero eight zero for o- zero four zero."

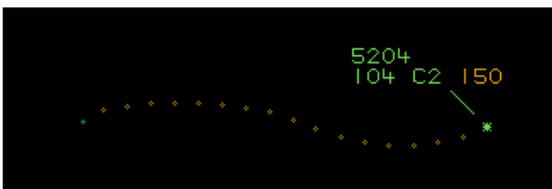
Figure 5: (Swanwick MRT) 1436:42

The A340 eventually reached a Mode S heading of 114° at 1436:13 before commencing a L turn. Figure 5 shows the 4sec interval trail history of the A340 at 1436:42.
