AIRPROX REPORT No 2012065

Date/Time: 14 May 2012 2135Z (Night)

Position: 5108N 00146W
(1km WSW RW35 THLD
Boscombe Down
- elev 407ft)

Airspace: ATZ (Class: G)

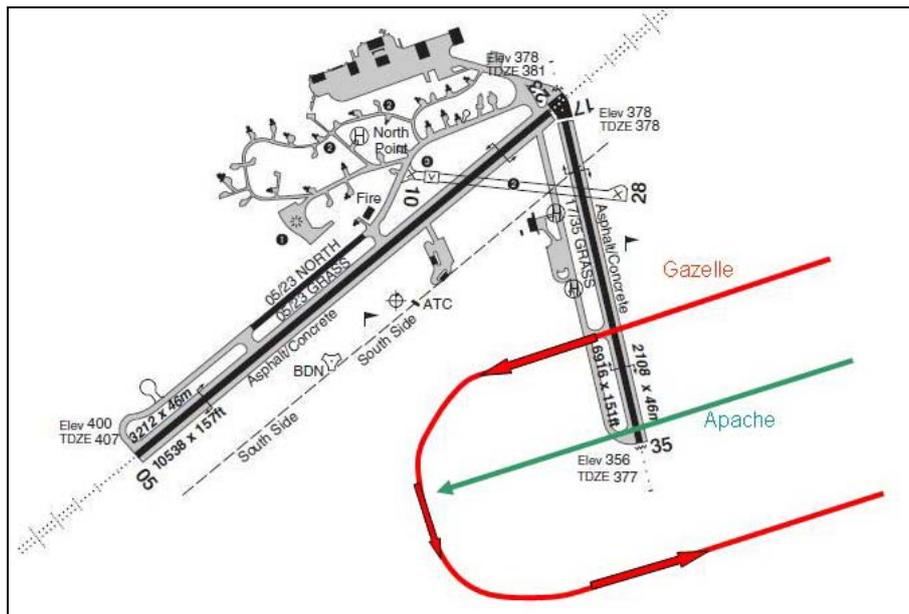
Figure 1: Boscombe Down with Operating Locations of Gazelle & Apache

The incident sequence commenced at 2121:59 as the Gazelle got airborne to conduct left-hand circuits, remaining South-side, from the intersection between Twy K and RW35 (see Figure 1). The Gazelle sought confirmation from the ADC that they could operate negative R/T, which was confirmed at 2123:30. The then extant Boscombe Down FOB, Order 6, Para 7 m (i), stated that '...helicopters may operate South-side autonomously between ground level and 500ft QFE...When operating autonomously pilots are to maintain a listening watch on [the TWR freq]'; the FOB did not differentiate between day or night in this order.

At 2129:46, the Apache stated that they were, "established south-side to operate threshold runway 35" (see Figure 1). The ADC asked them to, "confirm visual with the Gazelle" to which the Apache replied, "[c/s] visual". The ADC acknowledged this visual call and informed the Apache that they were, "happy for you to work negative R-T south-side", which was read-back by the pilot.
