AIRPROX REPORT No 2012075

Date/Time: 2 June 2012 0804Z (Saturday)

Position: 5114N 00021W
(OCK HOLD)

Airspace: Lon TMA (Class: A)

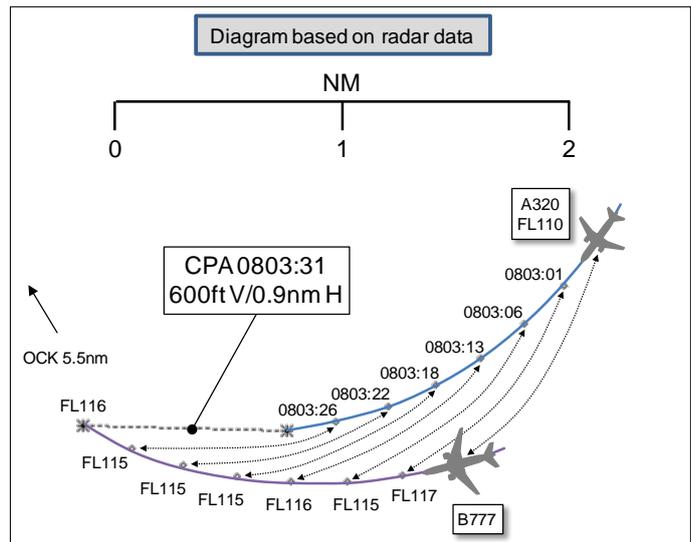
At 0803:31 (CPA) B777 [C/S A] was climbing through FL116 to FL120 and the A320 was at FL110; the lateral distance between the two ac was 0.9nm

The Airprox occurred in Class A airspace in the vicinity of the OCK hold when the crew of B777 [C/S A] took an instruction meant for a B747 [C/S B] with a similar callsign and flew into conflict with an A320.

Cause: The B777 crew actioned an ATC instruction intended for another aircraft and descended into conflict with the A320.

Degree of Risk: C.
