## AIRPROX REPORT No 2012092

Date/Time: 2 Jul 2012 1104Z

Position: 5109N 00011W (O/H RW26L  
Gatwick - elev 203ft)

Airspace: Gatwick ATZ (Class: D)  
Reporting Ac Reported Ac

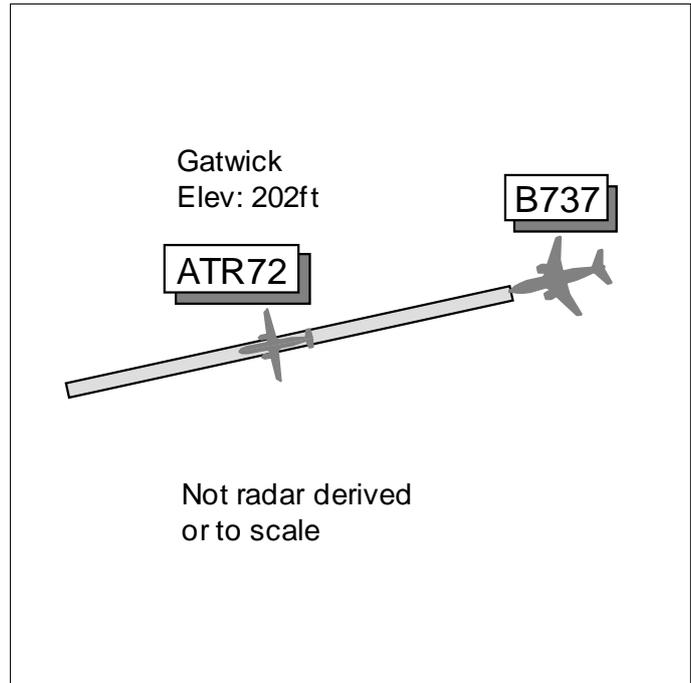
The B737 crossed the beginning of the RW before the ATR72 became airborne at 1104:10. The B737 crew was given landing clearance just after it crossed the beginning of the RW, and landed safely.

[UKAB Note (1): The Unit report states that when the ATR72 became airborne separation was eroded to 1148m and this reduced to 940m when the B737 touched down, distances taken from the ASMGCS.]

The remaining gap available to the AIR controller was insufficient to allow the A320 and the ATR72 to depart with appropriate spacing from the landing B737. As a result the B737 was given late landing clearance, after it had crossed the beginning of the RW.
