AIRPROX REPORT No 2012096

Date/Time: 7 Jul 2012 1047Z (Saturday)

Position: 5202N 00056W (3½nm
SE of Silverstone Heliport
– elev: 502ft)

Airspace: Silverstone RA(T) (Class: G)

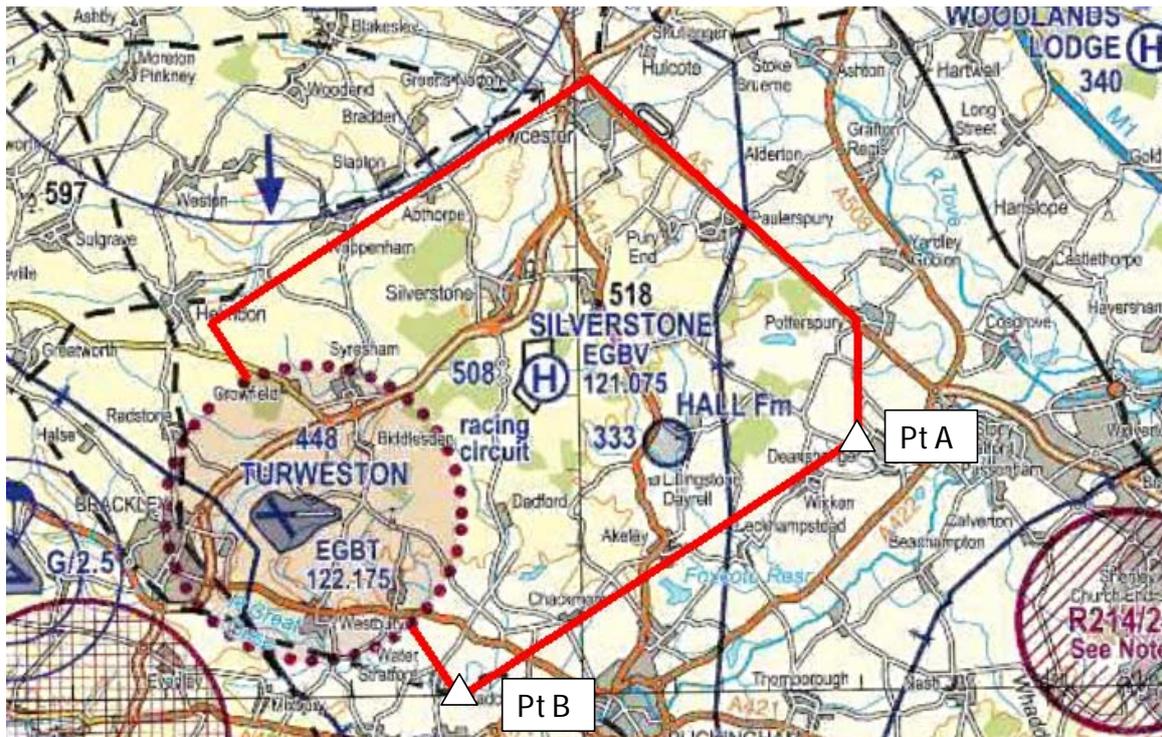
Figure 1

ATSI reports that the Airprox was reported to have occurred in the RA(T) established in Class G airspace for the Silverstone Grand Prix between an EC135 helicopter and a formation of 6 YAK50 ac. The RA(T) was notified by NOTAM and Aeronautical Information Circular (AIC - M034/2012) as being active between 0700 and 1800 on the 7th July 2012 from the surface up to 2500ft amsl and is illustrated at Figure 1. According to the AIC no aircraft were to fly in the RA(T) established for Silverstone unless the pilot informed the ATSU immediately before entering the area of the ac's

position, level and track, flew in accordance with ATC instructions and maintained a continuous listening watch on 121.075MHz.

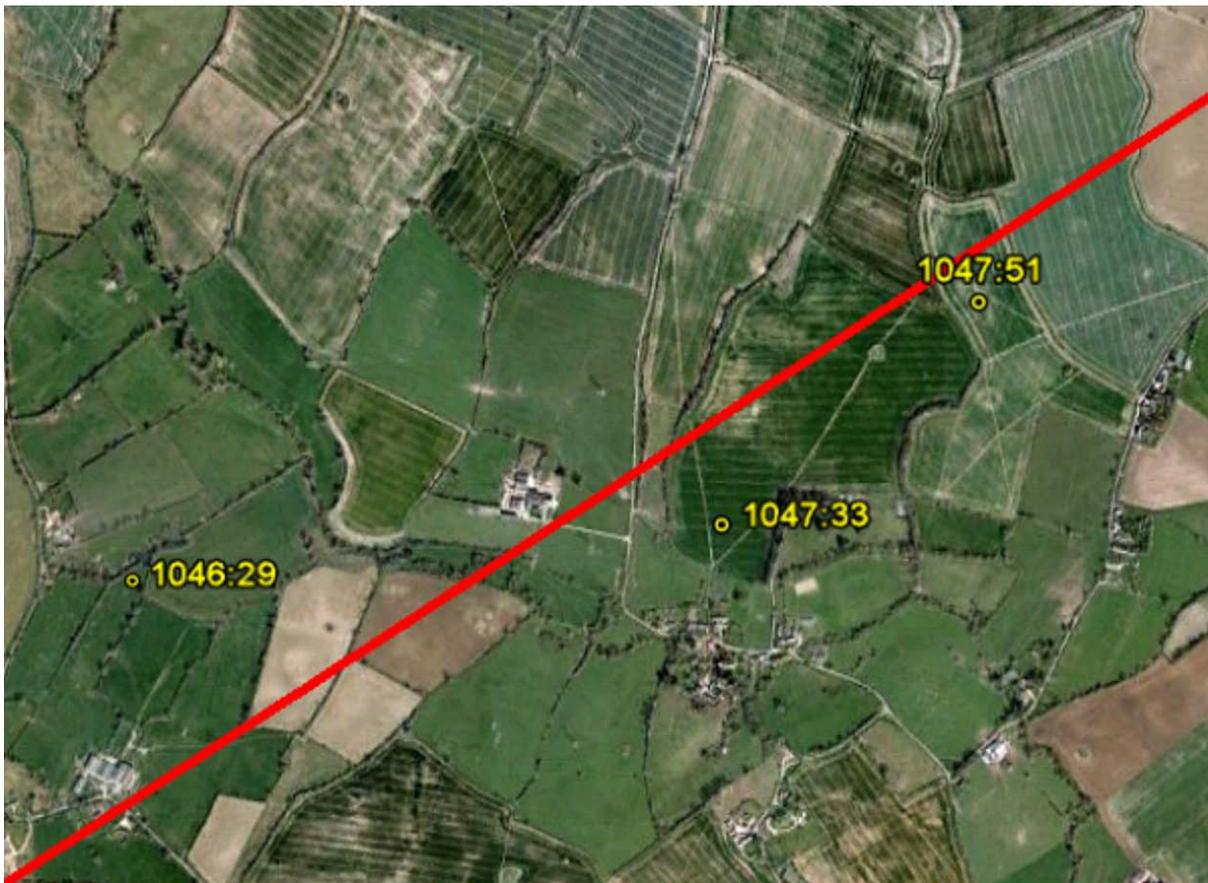
[UKAB Note (1): Analysis of the Clee Hill radar recording shows a sequence of single primary returns that in all probability is an element of the YAK50 formation (no other primary returns are shown that might be the formation ac), positioned to the S of the plotted Silverstone RA(T) boundary line between Pts A – B, tracking broadly NE'yly. (The plotted boundary line co-ordinates have been

corrected for the correspondence error between the OSGB36 and WGS84 datums.) It is not feasible to identify if this single primary return is the entire formation or an individual element; at 1047:12 it is in the EC135's 11:30 position at a range of 1-3nm. The EC135 shows a track alteration R and then L (which might be the result of track jitter) before closing to a range of 0.5nm from the YAK50 element at 1047:33, which is still S of the RA(T) boundary. The next sweep shows the YAK50 element has closed to a range of 0.3nm, in the EC135 pilot's 11:30 position, the latter maintaining 1100ft QNH (1007hPa). The YAK50 formation element crosses ahead of the EC135 from L – R, in between sweeps and at 1047:49, is shown in the EC135's 2 o'clock at the minimum recorded horizontal separation of 0.2nm right on the plotted RA(T) boundary, as the helicopter indicates 1200ft ALT, moments before entering the RA(T). It is not possible to determine the minimum separation between the EC135 and the individual formation elements.]

Figure 2 shows the position of the primary returns relative to the southern boundary of the Silverstone RA(T) (in red) at the times indicated.
