AIRPROX REPORT No 2012148

Date/Time: 31 Aug 2012 1015Z

Position: 5218N 00047W
(RW21L Sywell A/D
- elev 400ft)

Type: Corby Starlet A109E

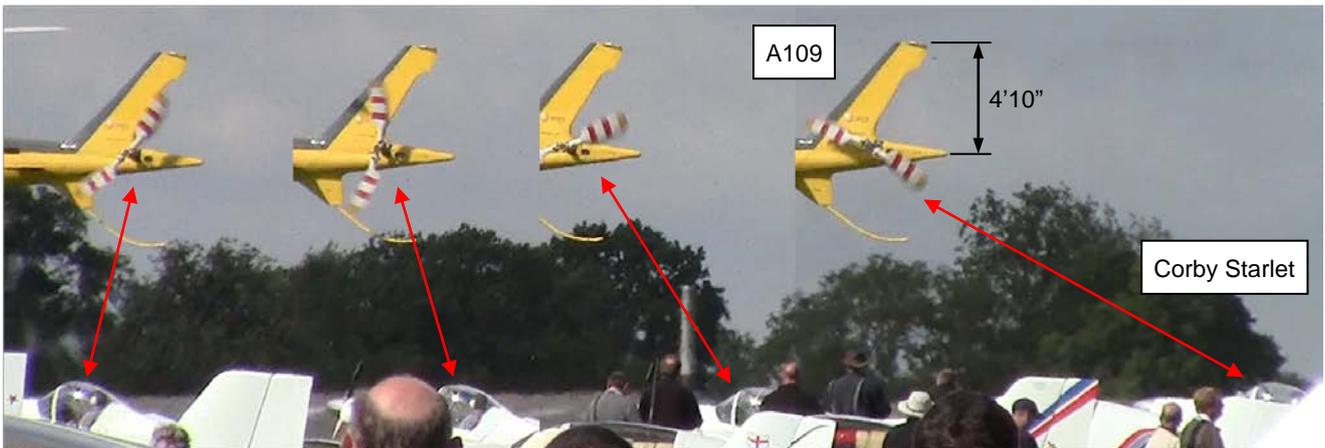
A few seconds later the front seat crewmember called 'Up Up!'. The A109 pilot saw an ac on the ground through the lower L 'chin' window, almost directly beneath him about 2-3ft below, which appeared to be taxiing in front of the helicopter. He applied maximum torque and moved the A109 backwards in a manoeuvre similar to that used during helipad Class 1 procedures in this model of helicopter. The light ac was seen to ground loop and then taxi off into the parking area.

[UKAB Note(3): The UKAB has obtained video footage of the seconds prior to the Starlet ground-loop. The composite image below illustrates the proximity of the A109 and the Starlet, travelling R to L across the frame:

The Starlet pilot slowed to exit L and applied L rudder. The ac then swung through approximately 90° to the R. The pilot initially believed that the tailwheel steering had failed and looked up, into the cockpit of the A109 directly O/H. The Starlet pilot continued to apply L rudder and eventually the ac responded. He moved to the L and vacated the RW.
