## **AIRPROX REPORT No 2012158**

Date/Time: 10 Oct 2012 1359Z

Position: 5133N 00009W  
(North Weald Base Leg  
RW02 LH - elev 321ft)

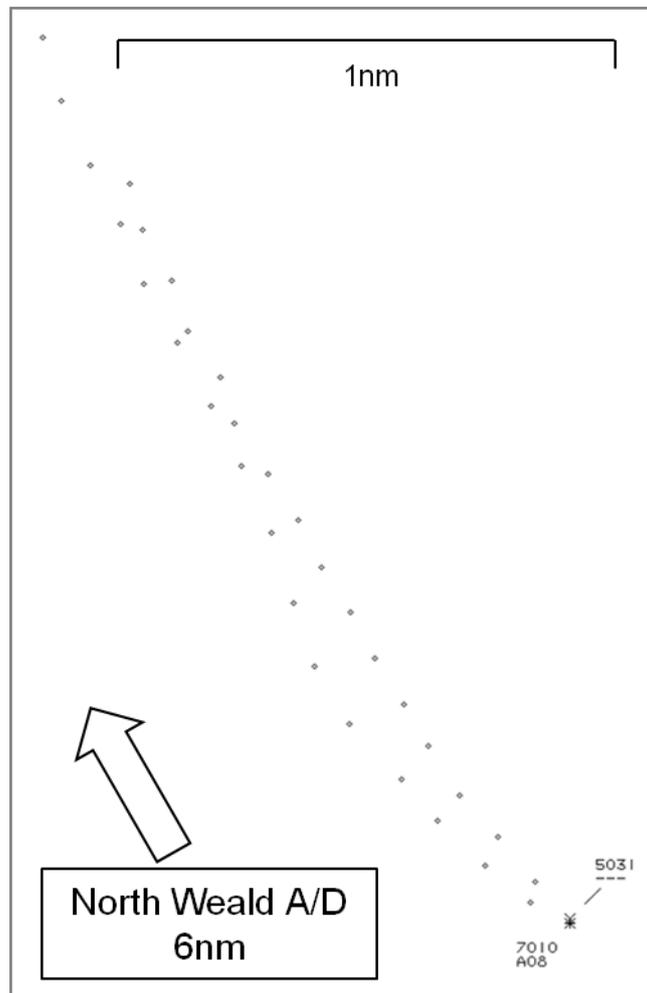
[UKAB Note(1): The Stansted 10cm radar recording at 1402:14 is reproduced below:

The radar contact trail is at 4sec spacing]

At 1402:18, the two ac contacts started to diverge as the Yak 50 commenced a L turn to the NE. The Yak 50 pilot contacted North Weald Radio and advised the operator of the Grob 115 ac's registration.
