AIRPROX REPORT No 2012057

Date/Time: 24 Apr 2012 2103Z (Night)

Position: 5731N 00349W
(23nm SW Lossiemouth)

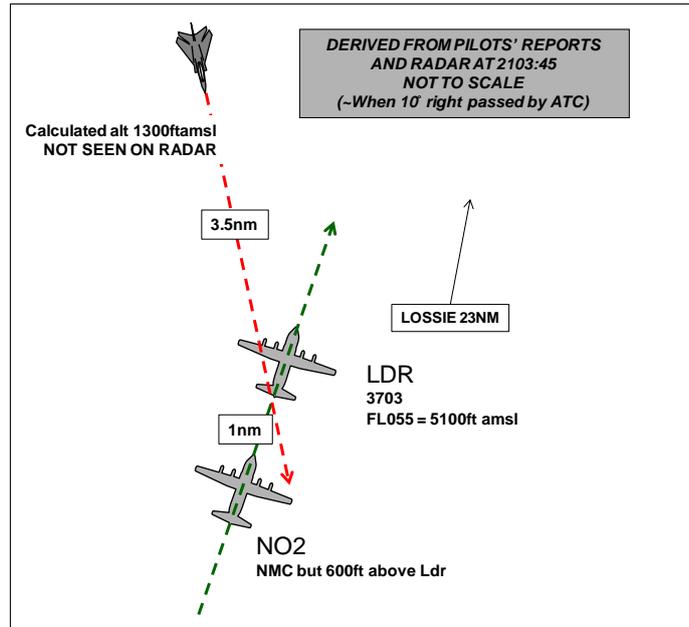
Cause: The Tornado crew climbed into conflict with the MC130P which they did not see.
