AIRPROX REPORT No 2012115

Date/Time: 4 Aug 2012 0609Z (Saturday)

Position: 5109N 00011W (Threshold
RW26L Gatwick - elev 203ft)

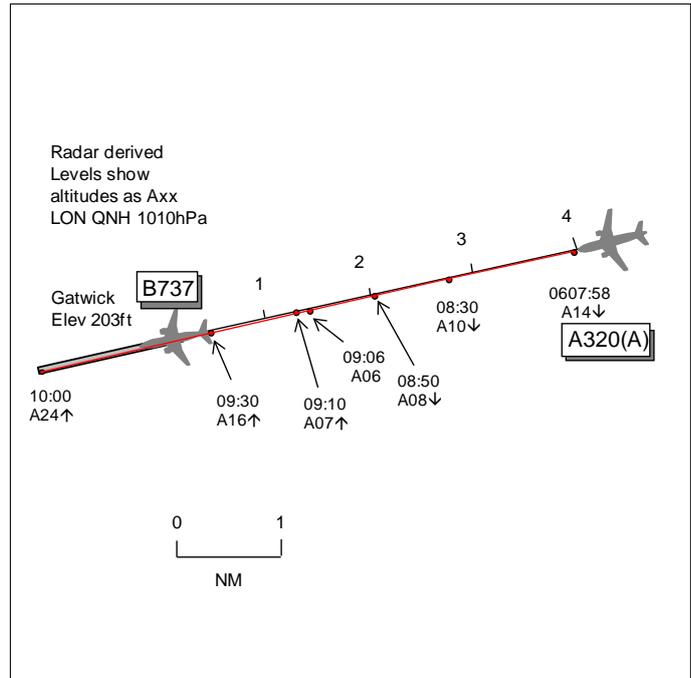
An Airprox was reported when a B737 and A320(A) came into conflict at Gatwick when A320(A) flight was given landing clearance by the AIR controller whilst the B737 flight was still on the RW awaiting take-off clearance.

Cause: The AIR controller cleared A320(A) flight to land while the B737 was on the RW awaiting take-off clearance.
