## AIRPROX REPORT No 2012135

Date/Time: 31 Aug 2012 0904Z

Position: 5114N 00044W (8nm E  
Odiham - elev 405ft)

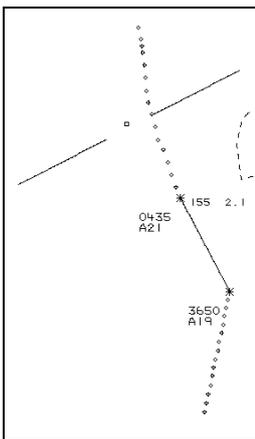
Figure 1: Pease Pottage 0903:26 UTC

Figure 1 below shows the Pease Pottage radar picture at 0903:26. The RC114 (#0435) is on track MID and the Griffin (#3650) was now slightly through the RC114's 12 o'clock at 2.1nm, altitude 1900ft.

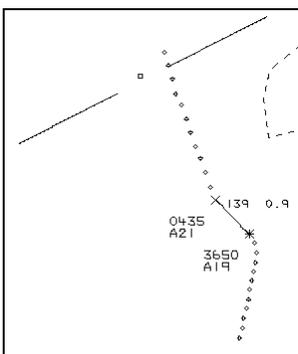
Figure 2: Pease Pottage 0903:44 UTC

At 0903:44 (Figure 2) the Griffin had begun to turn left towards the track of the RC114. Distance between the 2 ac was 0.9nm and 200ft.

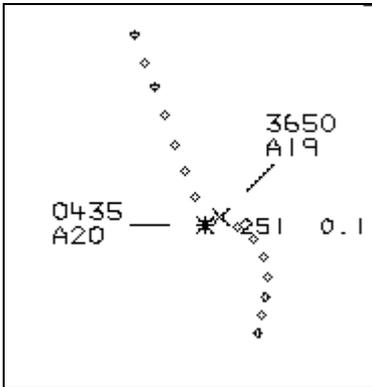
Figure 3: Pease P. 0903:57 UTC

At 0903:56 the ac were 3nm SSE of Farnborough at the CPA. The Griffin was now 0.1nm abeam the RC114 and 100ft below (Figure 3). The Griffin then passed behind the RC114 by 0.3nm (Figure 4). The Griffin pilot report indicates that the crew became visual with the RC114 as the Griffin turned to intercept the LOC. The RC114 pilot's report does not specifically note that the Griffin was sighted visually.
