## AIRPROX REPORT No 2013026

Date/Time: 29 Apr 2013 1303Z

Position: 5154N 00210W (Final  
RW27 Gloucester Airport  
- elev 101ft)

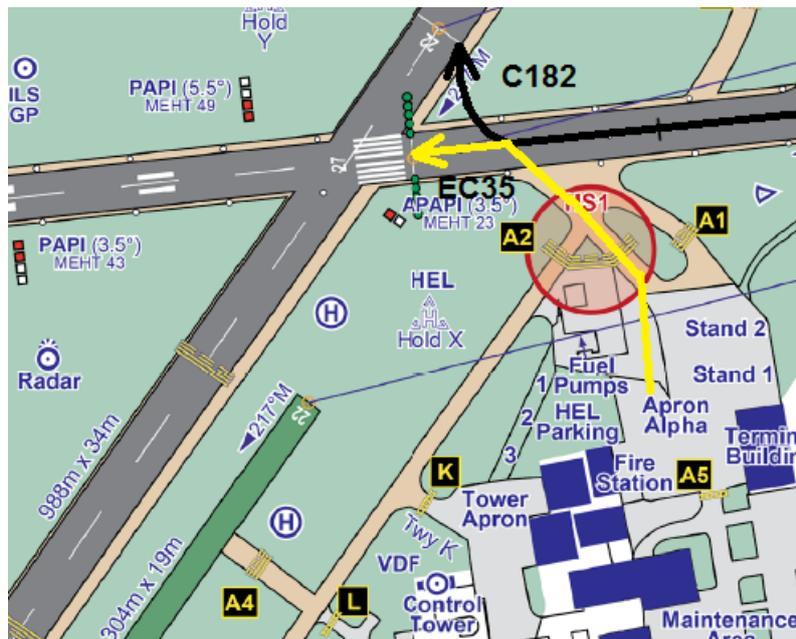
Figure 1

The C182 was operating VFR in the visual RH cct for RW27 and was approaching short final on a glide approach for a full stop landing. The C182 was in receipt of an Aerodrome Control Service (BS) from Gloster Tower on frequency 122.9MHz. The EC135 was departing from the Apron, S of the refuelling area and just out of sight of the VCR (Figure 1) for a VFR W'ly departure to the Forest of Dean and was in receipt of an Aerodrome Control Service (BS) from Gloster Tower on frequency 122.9MHz.

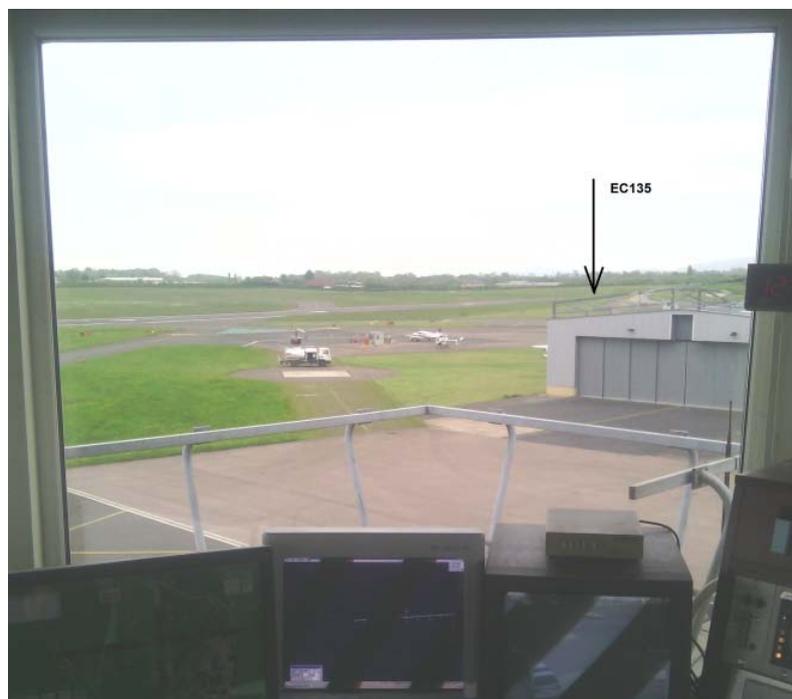
**Figure 2. View from the VCR**

The C182 was in the RH cct for RW27 and the EC135 was situated on the Apron adjacent to the refuelling point and was just out of the line of sight from the Tower (Figure 2).

When questioned, the ADC indicated that the EC135 appeared from behind the hangar and viewed from the VCR, due to parallax, it was difficult to determine if the EC135 was routeing towards X-ray or the runway. The controller's expectation was that it was routeing S of the Rwy. However, when the controller recognised that the EC135 had entered RW27 at the threshold whilst the C182 was on short final, it was too late to react. The C182 was observed to take avoiding action by executing a 90° R turn. The controller indicated that the C182 was observed to be approximately 100ft above the EC135.
