## **AIRPROX REPORT No 2013110**

**Date/Time:** 11 Aug 2013 1021Z (Sunday)

**Position:** 5113N 00100W  
(2.2nm WSW of Odiham)

**Airspace:** Odiham MATZ (Class: G)

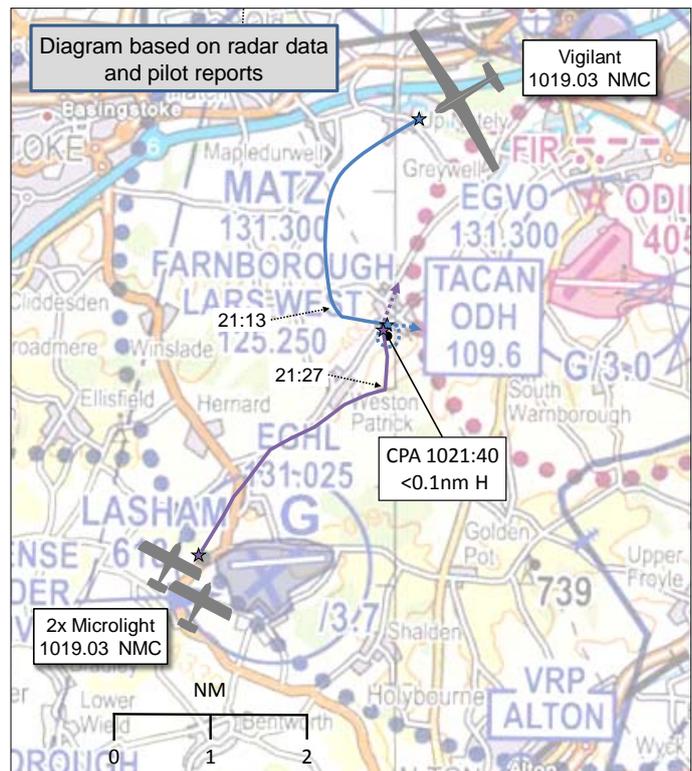
Analysis of the radar recording shows the Vigilant 3.2nm west-northwest of Odiham, tracking southwest, whilst the microlights can be seen 1.1nm northeast of Lasham tracking northeast. The Vigilant makes a wide turn on to an easterly heading commensurate with positioning for downwind for Odiham RW27, whilst the microlights continue on a broadly northeasterly track, showing some minor manoeuvring en-route. The CPA occurs at 1021:40 when the radar returns merge 2.2nm west-southwest of Odiham. The Vigilant can be seen to complete a right-hand orbit, which appears to commence at the CPA. The microlights continue in a northwesterly direction; whilst the radar shows that their track takes them either just on, or just inside, the outside edge of Odiham's ATZ, the tolerance of the radar recording means it cannot be determined positively. Notwithstanding, the Airprox event is shown to occur outside the ATZ.

The Airprox occurred in Class G airspace, 2.2nm to the west-southwest of Odiham between a Vigilant and two untraced microlights which departed from Lasham.
