AIRPROX REPORT No 2013125

Date/Time: 4 Sep 2013 1606Z

Position: 5121N 00133W
(Rivar Hill Glider Site
- elevation 730ft)

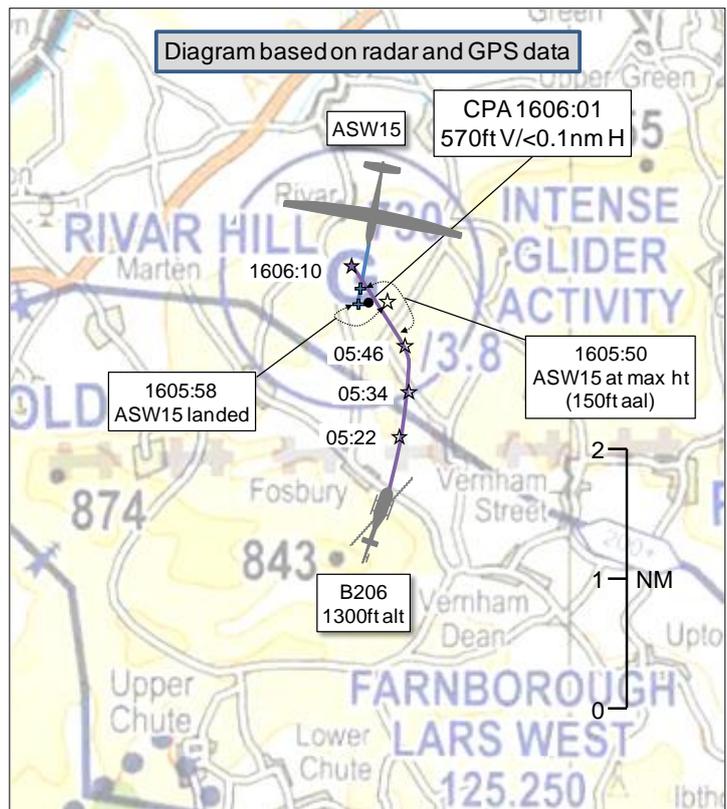
Recorded Separation:
570ft V/<0.1nm H

This incident occurred in the vicinity of the Rivar Hill gliding site, at approx 1606 on 4th September 2013, between a glider and a Bell 206. The glider pilot was in the process of winch launching from Rivar Hill. The Bell 206 was operating VFR in receipt of a Basic Service from Boscombe Zone. NATS surveillance radars did not detect the glider; however, the Bell 206 was visible and, as it crossed through the Rivar Hill glider site, maintained an indicated altitude of 1300 ft, based on the London QNH of 1018hPa, as used on the radar replay. This correlates with the Bell 206 pilot's report of maintaining 1300ft on 1017hPa.
