AIRPROX REPORT No 2013137

Date/Time: 22 Sep 2013 1525Z (Sunday)

Position: 5150N 00150W
(Northleach Roundabout VRP)

Type: Vigilant T1 C172

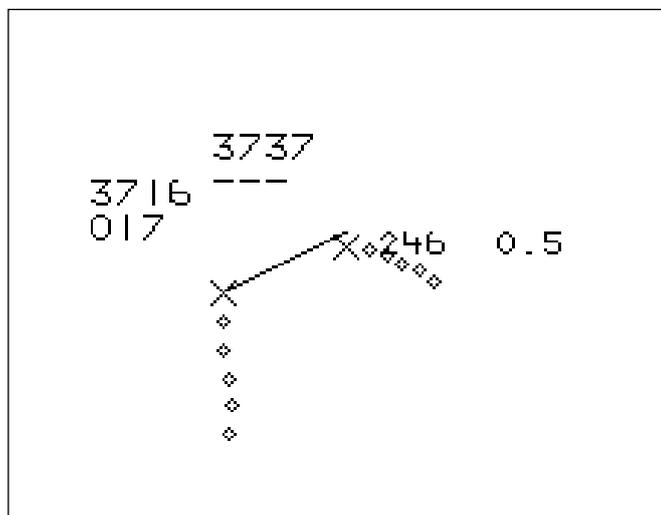
Analysis of the radar replay at 1524:48 determined that the Vigilant, squawking 3737 and the C172, squawking 3716 were 0.5nm apart on a converging heading with the speed of C172 expected to take it ahead of the Vigilant (see Figure 1 below).

Figure 1: Vigilant in relation to the C172 at 1524:48.

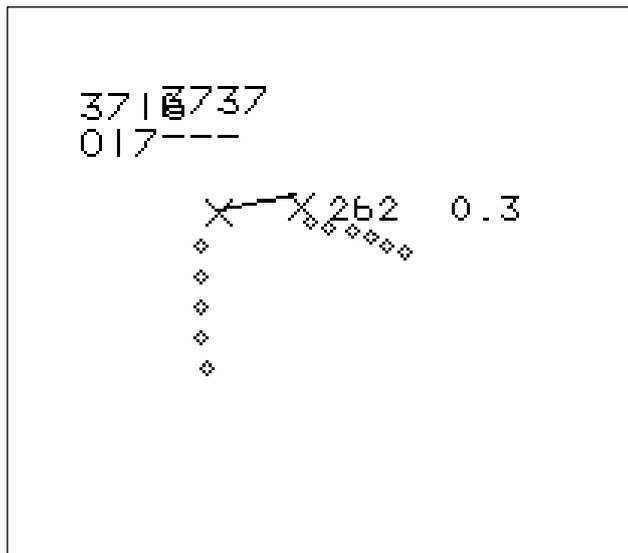
At 1524:56, the C172 pilot altered course to the right, taking it within 0.3nm of the Vigilant. No height information was available for the motor-glider but the C172 was indicating 1700ft on the London QNH 1028hPa.

Figure 2: Incident geometry at 1524:56.

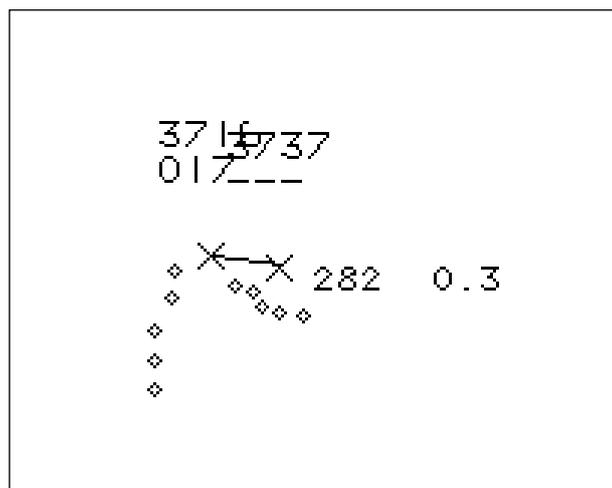
At 1525:04 the Vigilant can be seen taking a sharp right hand avoiding action turn which maintains the separation on radar replay at 0.3nm.

Figure 3: Incident geometry at 1525:04.
