**THE FOKKER F50 PILOT (F50)** reports that he was inbound to LCY, IFR. As far as he could recall, wing strobe lights were illuminated. He had been vectored by Thames Radar from the Detling VOR to a downwind right-hand position, south of the runway, for a landing on RW09 at LCY. The weather conditions at the time were very showery and turbulent, with a strong southerly wind. The RJ1H pilot ahead of him had asked for weather avoidance headings which had resulted in the RJ1H being north of the airport and being vectored for a left-hand circuit onto RW09. As the F50 pilot's aircraft approached the 'Alexandra Palace' TV mast at 2000ft he was fully visual with the ground. The controller instructed him to make a left-hand orbit in his present position (south of the airport) because the pattern was too tight with the RJ1H, which was on a left-hand base-leg position. A left-hand orbit was commenced and, as he rolled out back onto the downwind heading, the controller instructed him to make a further left turn away from the airport. He suspected that the strong southerly wind had blown him closer to the RJ1H on final approach than expected. He did not receive a TCAS RA alert or sight the RJ1

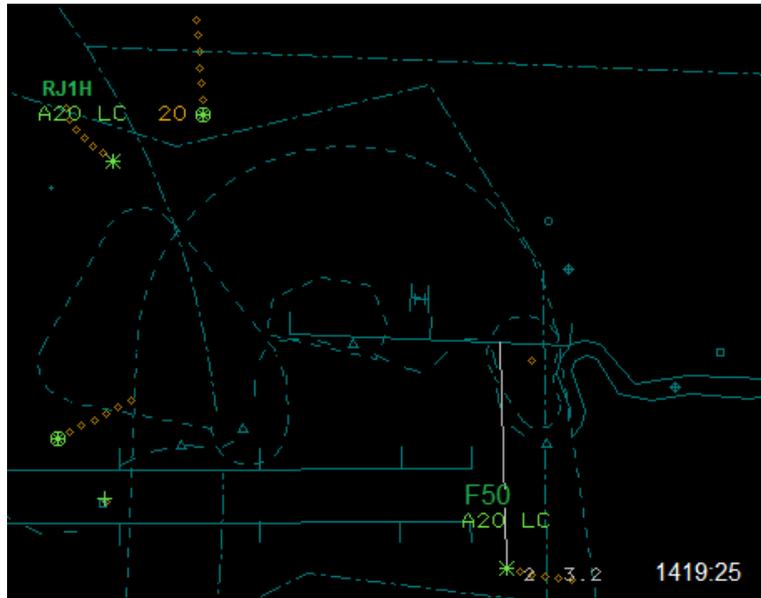
Figure 1.

At 1419:25, the RJ1H was on a closing heading and the F50 was 3.2nm south of the final approach track for LCY (Figure 1).

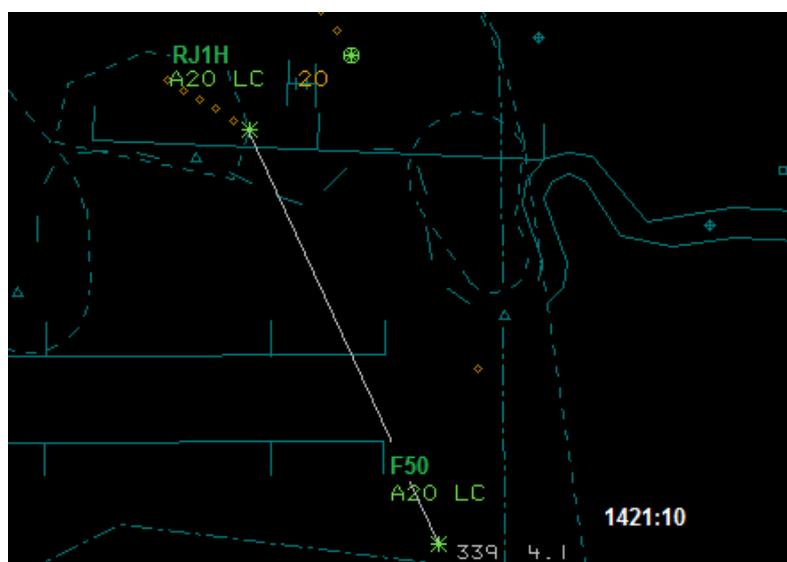
Figure 2.

At 1421:10, as the F50 pilot was completing his orbit, the RJ1H pilot was about to establish on the localiser, 4.1nm to the north-northwest of the F50 (Figure 2).

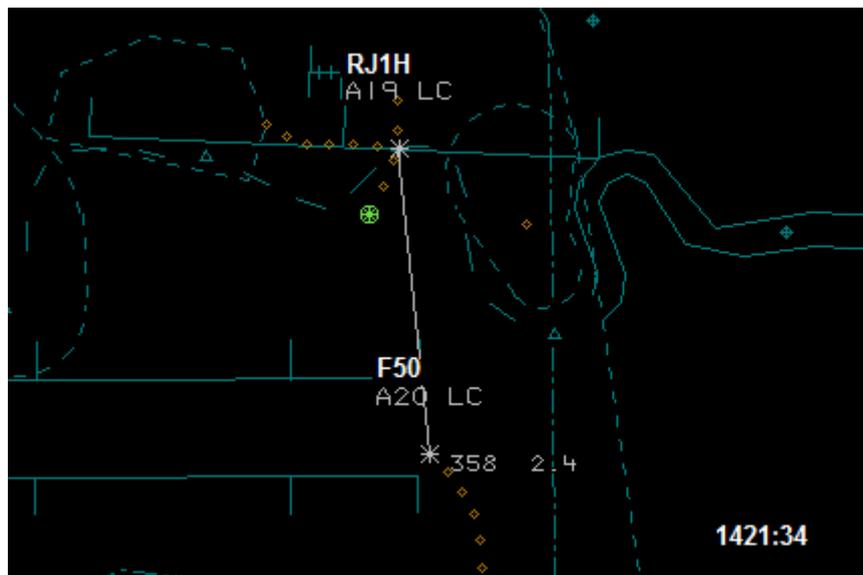
Figure 3.

As the F50 pilot turned left, the aircraft converged: at 1421:34, CPA, the two aircraft were 2.4nm horizontally and 100ft vertically apart and High-level STCA had reduced to Low-level (Figure 3).

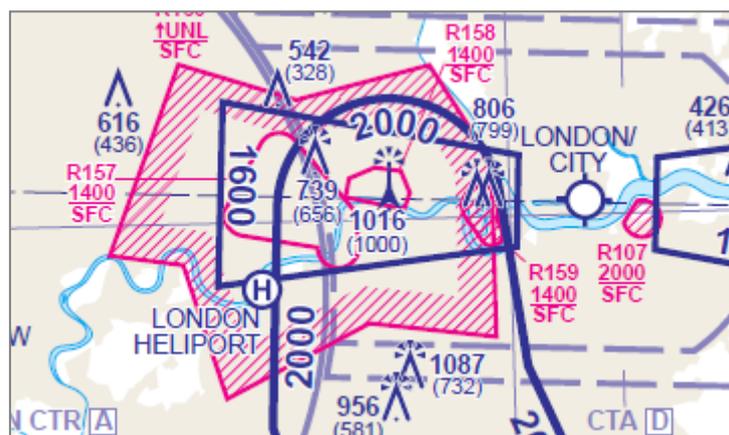
Figure 4.

An extract from the Surveillance Minimum Altitude Chart (SMAC) for LCY (Figure 4) shows that the minimum altitude to be allocated to the RJ1H pilot, within the final approach vectoring area, was 1600ft. Canary Wharf Tower is shown at 806ft amsl on the chart.

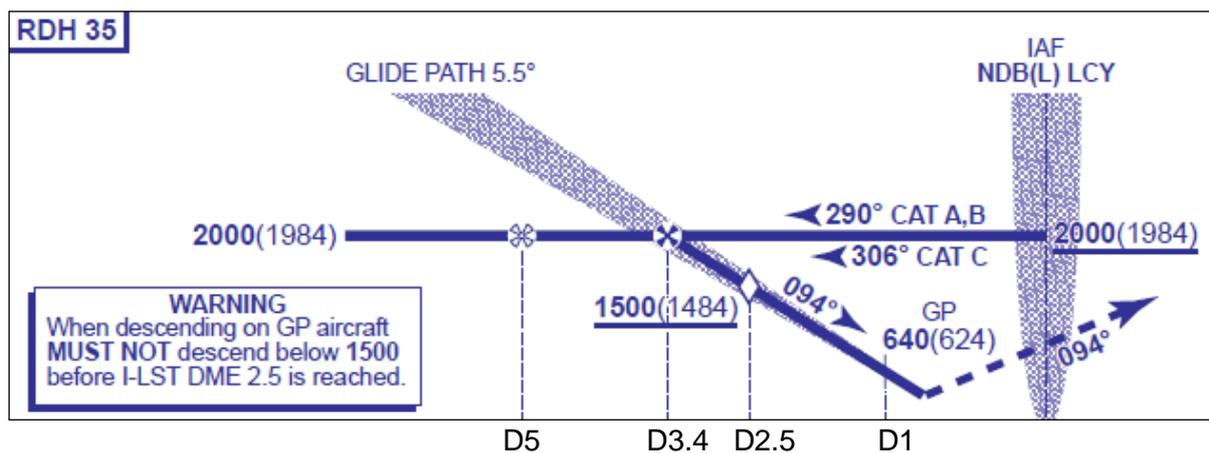
Figure 5.

There is also a restriction on the ILS chart for RW09 (Figure 5); the RJ1H descended through 1500ft as it passed 3 DME and 1200ft at 2.5 DME.
