## **AIRPROX REPORT No 2013179**

Date/Time: 20 Dec 2013 0929Z

Position: 5301N 00412W  
(Lleyn Peninsular)

Type: Hawk T1(A)              Hawk T1(B)

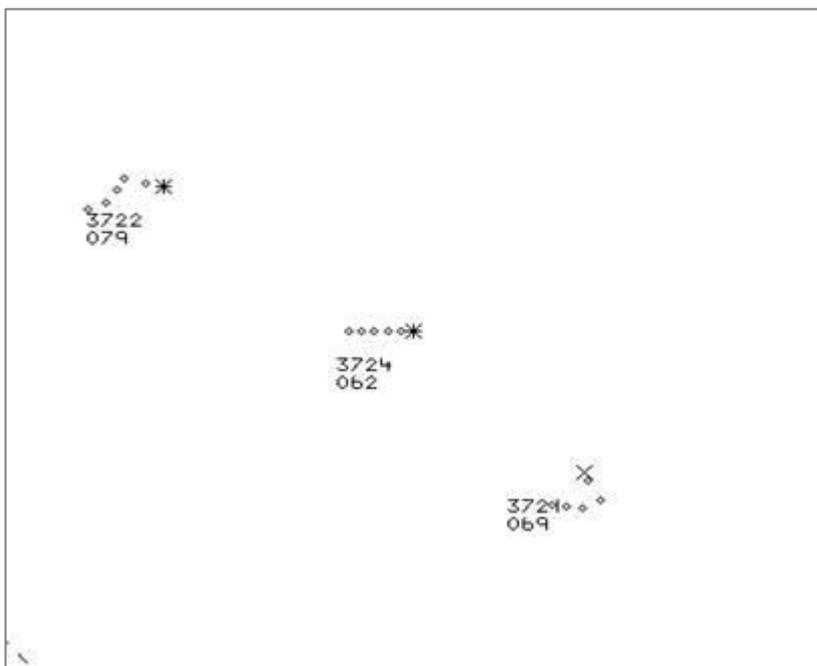
Figure 1: Aircraft geometry at 0927:41 (Mustang formation 3724; Obi formation 3722; Wizard formation 3721)

At 0927:41, the RAD called Traffic Information to Hawk Mustang formation, "*Mustang, traffic southeast five miles tracking er north, indicating no height information*". Figure 1 depicts the geometry of the traffic; the radar replay displays Mode C height information but the SUP confirmed that due to the high energy manoeuvres, the Mode C was not always painting on the Valley radar and height information was passed when showing on screen. The RAD updated the information to confirm that the traffic was no longer a factor.

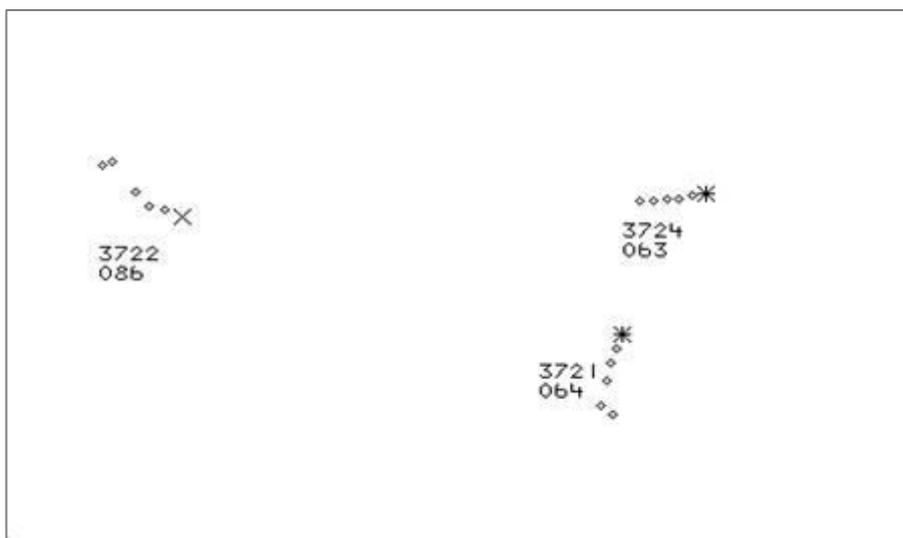
Figure 2: Aircraft geometry at 0928:54

At 0928:54, Traffic Information was passed to Wizard formation, “*Wizard, traffic northeast three miles, pair manoeuvring, tracking west, no height information*”. Figure 2 depicts the geometry and confirms that the traffic was in fact heading east and not west.

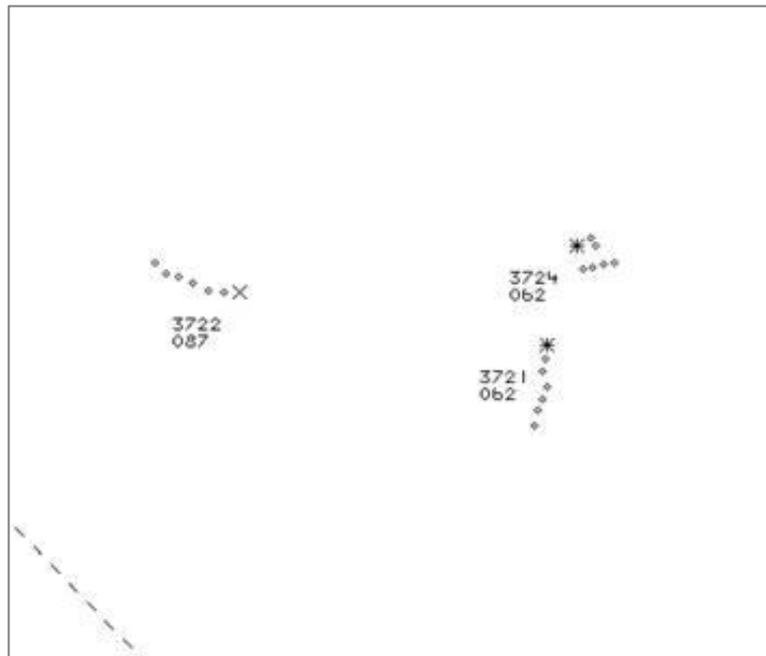
Figure 3: Aircraft geometry at 0929:03

An update was provided at 0929:03 to provide height information; at this point the formations indicated the same height on radar replay with 3.7nm horizontal separation, see Figure 3. Neither Traffic Information calls were acknowledged by Wizard formation. The controller delayed his transmission to Mustang formation because he waited for an answer to avoid dual transmissions.

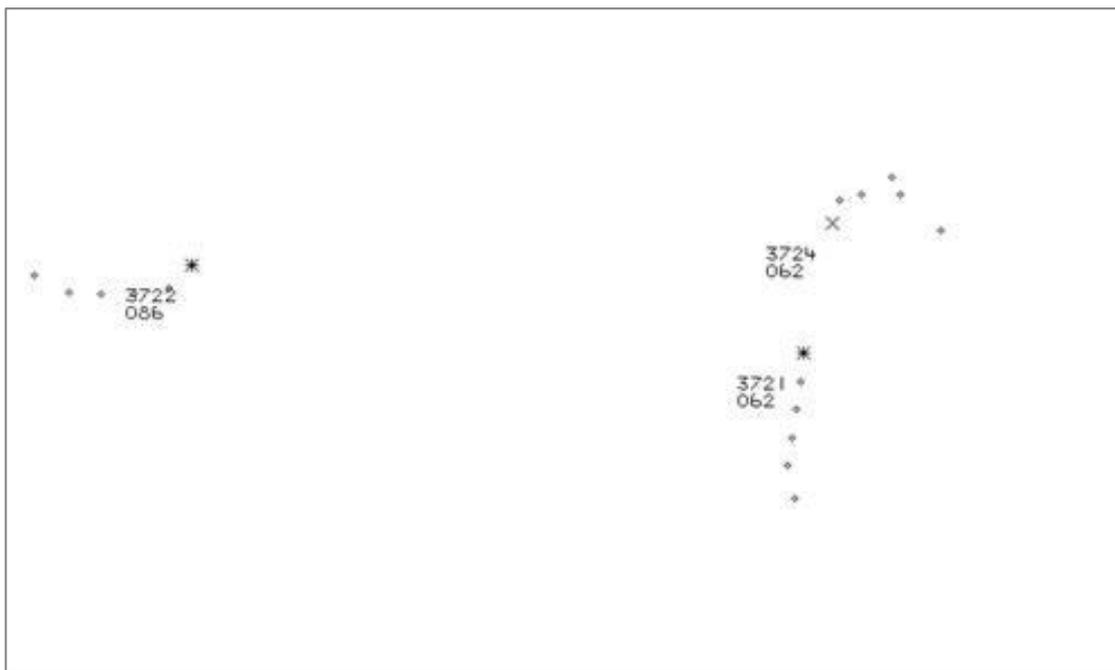
Figure 4: Aircraft geometry at 0929:13

At 0929:13, Mustang formation turned to the south, taking their track towards the other formation (see Figure 4), prompting Traffic Information, “*Mustang, traffic south west, 1 mile tracking er north indicating er altitude 6300 feet*”. Mustang formation did not respond to the RAD.

The CPA from radar replay occurred at 0929:25 with 0.8nm horizontal separation, which did not capture the exact Mode C of Wizard formation; the crews of Mustang formation put the separation at 100ft horizontal and 300ft vertical. At 0929:31, Wizard formation responded to earlier Traffic Information with, “*Wizard, copied. We er saw that traffic, we were talking on internal frequency*”. A further update was requested by the Wizard formation and after confirmation that the other formation had got ‘uncomfortably close’ the Wizard formation requested information on all aircraft within a 5nm radius.
