## **AIRPROX REPORT No 2013181**

**Date/Time:** 29 Sep 2013 1655Z (Sunday)

**Position:** 5118N 00005W  
(Overhead Kenley)

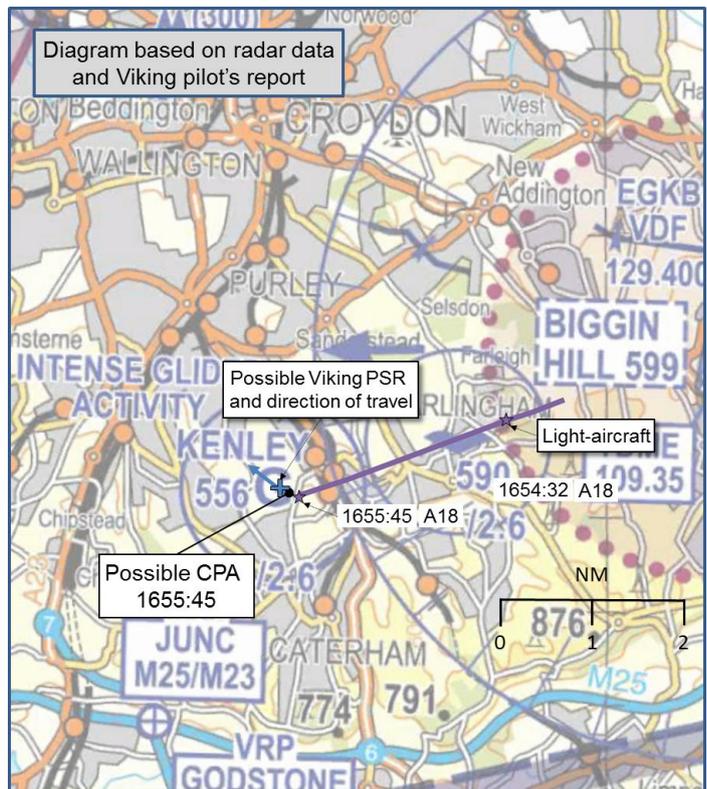
The relevant radar recording shows an SSR radar track appearing to the west of Biggin Hill, on a southwesterly track, indicating an altitude of 1800ft. The aircraft passes just to the southeast of Kenley glider site close to the time of the reported Airprox. A PSR<sup>1</sup> return can also be seen intermittently on the recording; it appears just to the northwest of the SSR return and tracks to the northwest; however, the track of this primary return is not commensurate with the Viking pilot's reported heading. The Mode C of the SSR track indicates 1800ft which, assuming the QNH of the time of 1007hPa, equates to 1530ft on the Kenley QFE of 997hPa (1hPa=27ft); this altitude also does not correspond with the Viking pilot's report. Whilst the occurrence seen on the radar recording matches the time off the Viking pilot's report, because the light-aircraft pilot could not be traced the anomalies could not be investigated further and it was therefore not possible to reconcile the differences.

An Airprox was reported overhead Kenley glider site, in Class G airspace, between a Viking glider, which was just completing its winch-launch, and a light aircraft; the light aircraft could not be identified nor its pilot traced. By the time the Viking pilot saw the light-aircraft, he deemed that there was no longer any risk of collision and decided no avoiding action was necessary.
