AIRPROX REPORT No 2013008

Date/Time: 12 Feb 2013 1335Z

Position: 5602N 00149W
(15nm NE SAB VOR)

Type: DA42 TwinStar FA20 Falcon

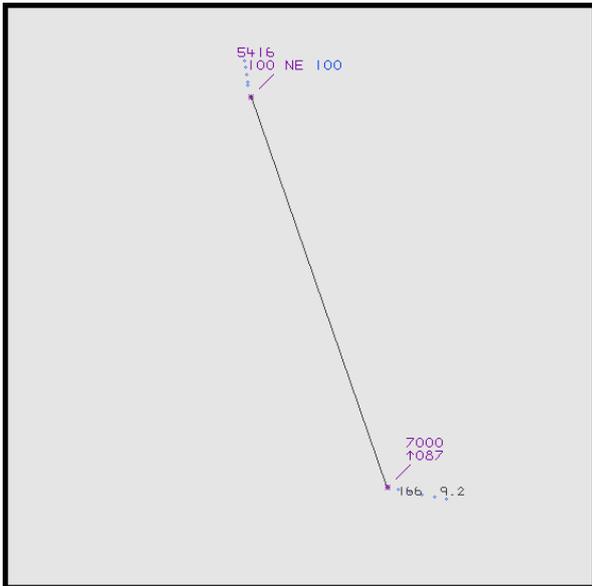
(Fig.1 – Prestwick MRT - 1326:02.)

At 1326:02, the controller instructed the DA42 to turn L heading 140° and advised of traffic 11 o'clock at a range of 8nm crossing L to R indicating FL090 unverified (Fig.1).

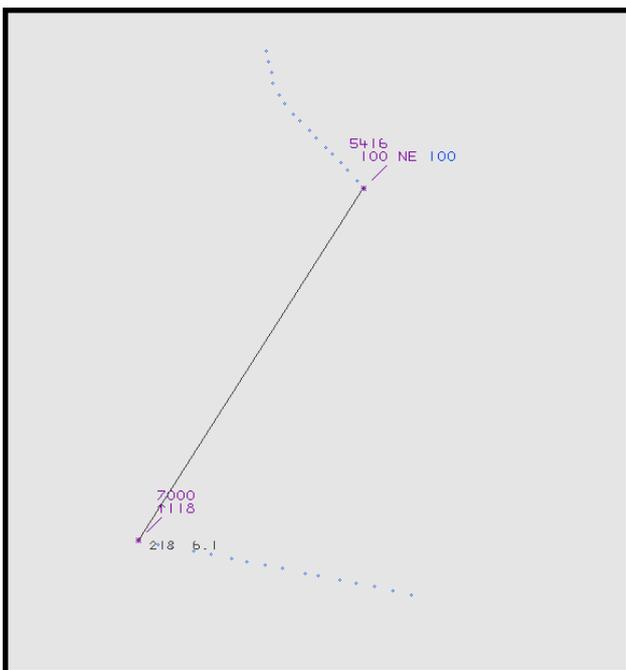
(Figure 2 – Prestwick MRT - 1327:16.)

At 1327:16, the DA42 flight commenced a R turn to resume own navigation for NATEB with the FA20 at FL118 (IAS 220kt) 6.1nm to the SW of the DA42, tracking away (Fig.2).

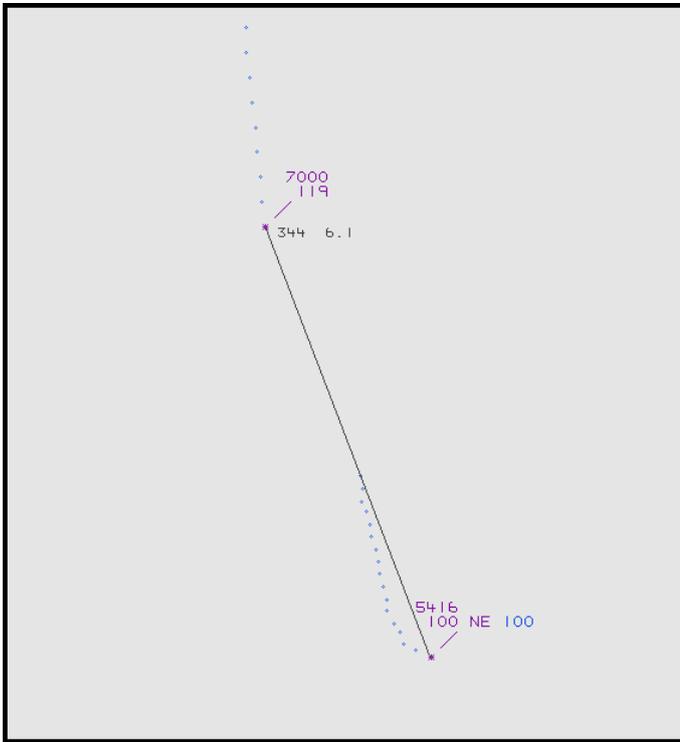
(Fig.3 – Prestwick MRT - 1332:09.)

At 1331:10, the controller advised the DA42 pilot that the unknown traffic was now in DA42's 6 o'clock, FL120, at a range of 8.4nm and at a faster speed. The DA42 pilot reported that they had lost sight of the other ac and at 1331:26 the controller instructed the DA42 to turn L onto heading 130°. The DA42 pilot asked if ATC knew who the other contact was and the controller responded that there was no way of telling, but it was likely to be military traffic and was indicating a speed of 260kt. The distance between the 2 ac reduced to 5.9nm and at 1332:09 the controller issued avoiding action, "(DA42 c/s) avoiding action further left turn heading 090 degrees that traffic is currently in your seven o'clock at a range of 5.9 miles indicating FL120 unverified" (Fig.3).

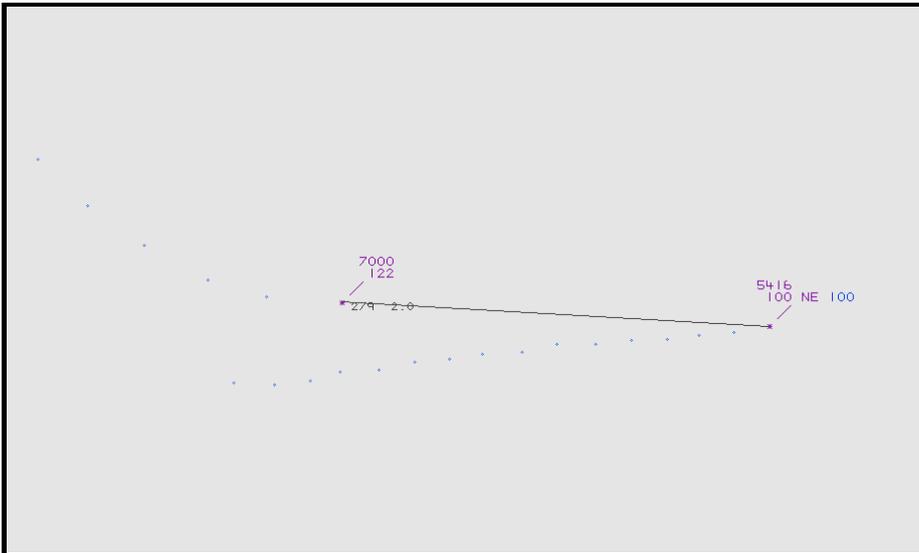
(Figure 4 – Prestwick MRT - 1333:41.)

At 1332:56 the controller updated the TI on the FA20 which was now 7 o'clock at a range of 4nm still indicating FL120 and tracking 170°. The deconfliction minima (5nm/3000ft) were lost at 1332:58. Radar showed the FA20 adjusting its heading to intercept that of the DA42. At 1333:14, the controller updated the TI indicating that the unknown traffic was 7 o'clock at 3nm indicating FL120 and turning towards the DA42. The controller then gave a further avoiding action L turn onto a heading of 040°. This was followed at 1333:44 by another avoiding action R turn onto a heading of 180°, with updated TI on the position of the unknown traffic, 6 o'clock at a range of 1.7nm at FL122 (Fig.4).

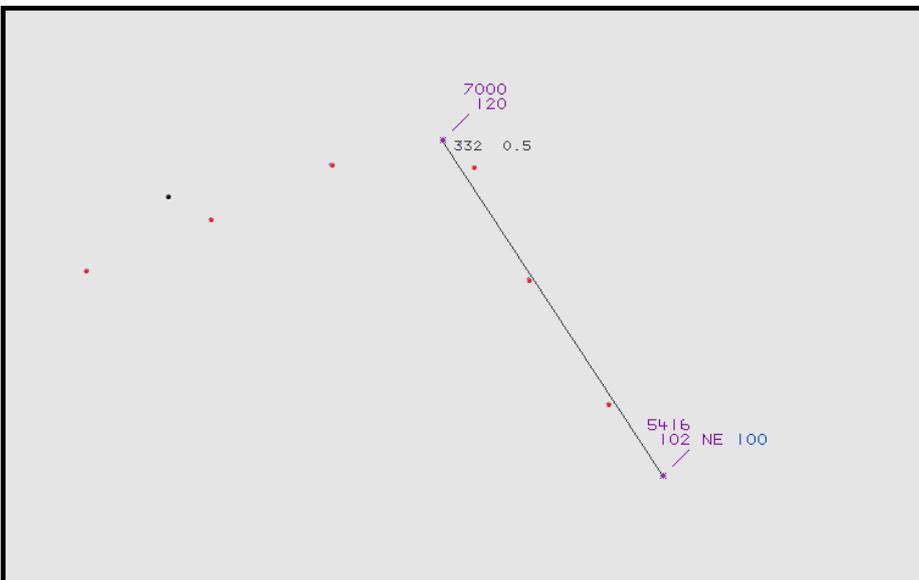
(Figure 5 – Prestwick MRT - 1334:17.)

At 1334:18, the DA42 pilot, (using non-standard phraseology) reported that the other aircraft (FA20) was very close (Fig.5).

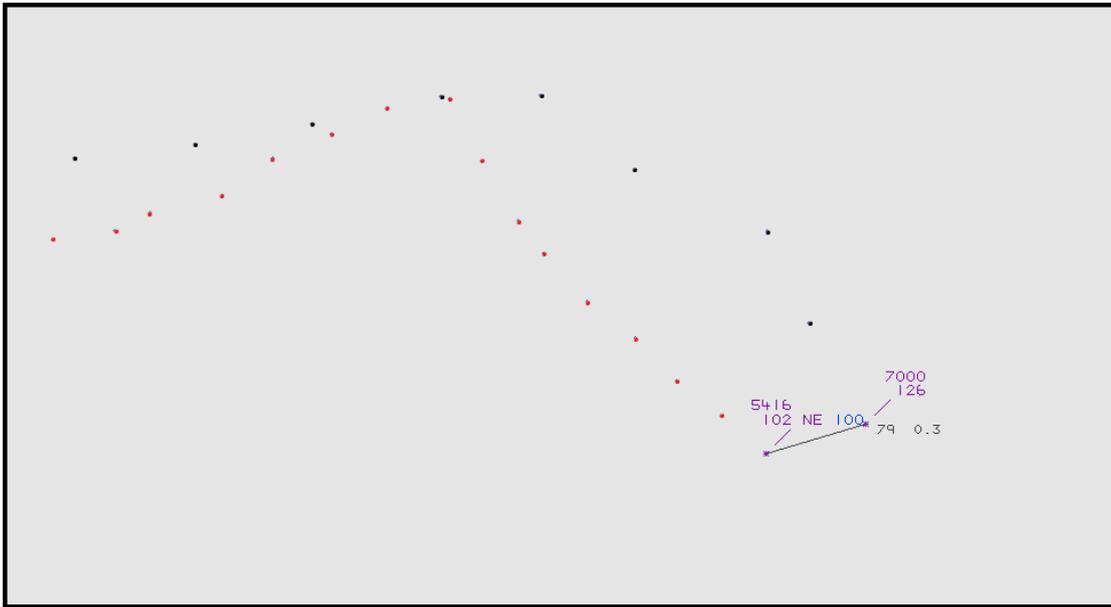
(Figure 6 – Area radar recording at 1334:37.)

As the FA20 turned R it climbed to FL127 and then descended to FL126. At 1334:38 the controller again issued avoiding action, instructing the DA42 flight to turn R onto heading 270°, reporting that the traffic was now directly above at FL126 indicating a descent. The lateral distance between the 2 ac was 0.3nm and the vertical distance was 2400ft (Fig.6).
