AIRPROX REPORT No 2013014

Date/Time: 14 Mar 2013 1059Z

Position: 5114N 00048W (2.5nm SSW
Farnborough - elev 238ft)

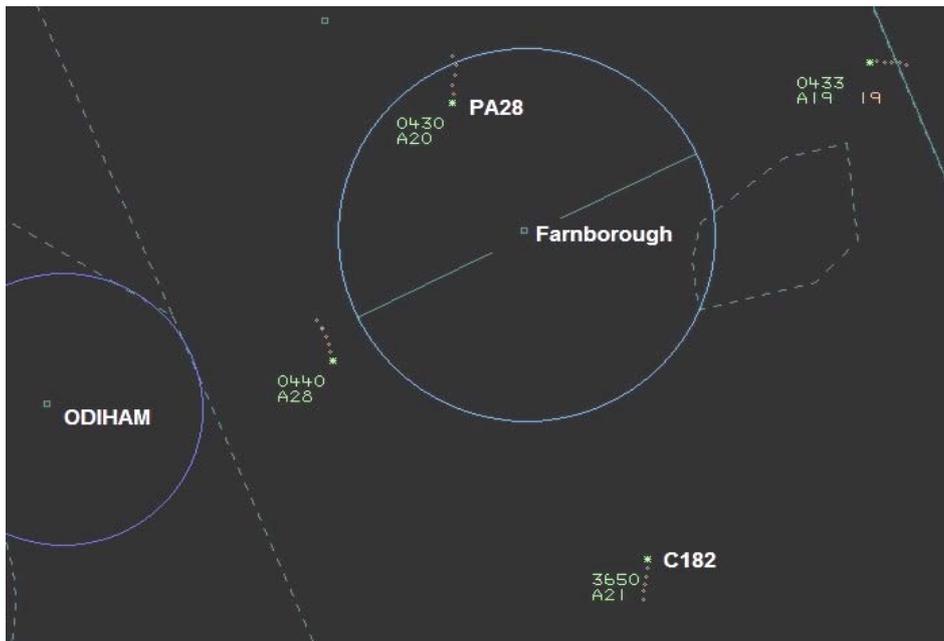
Figure 1 – Area MRT radar at 1056:54

The PA28 turned to enter the Farnborough ATZ at an altitude of 2000ft and changed squawk at 1056:54 as it tracked S'yly 2nm NNW of Farnborough. The C182 was 5nm SSE of Farnborough squawking 3650 tracking N at an altitude of 2100ft and on L base for the Odiham ILS RW27. For illustrative purposes the ATZ for each aerodrome has been overlaid below (figure 1).

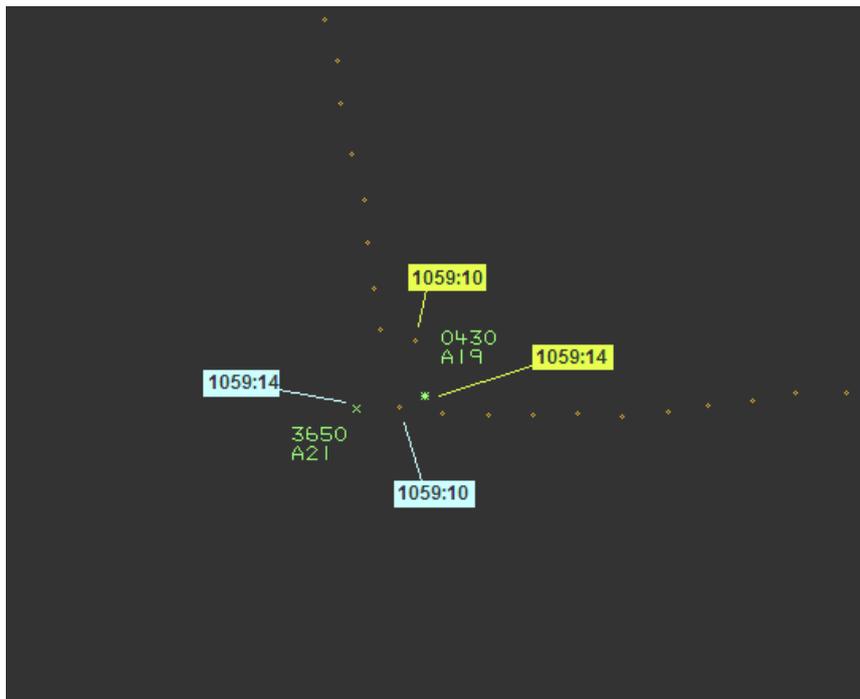
Figure 2 - Area MRT radar recording at 1059:14

At 1059:10 the distance between the ac had reduced to 0.2nm (CPA). Radar showed that the PA28 had turned L followed by a R turn to pass 0.2nm behind the C182 at 1059:14 (figure 2).

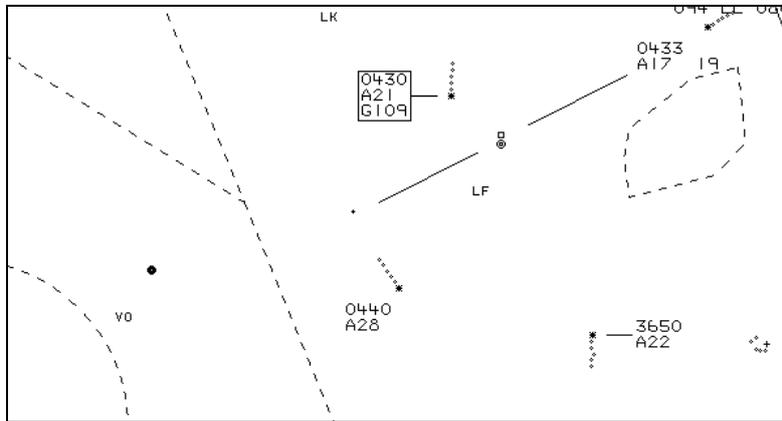
Figure 1: Incident geometry at 1057:33

The incident sequence commenced at 1057:33 as RAD instructed the C182 flight to “*...turn left heading three one zero degrees, report localiser established*” which was acknowledged by the C182 pilot. At this point, as depicted in Figure 1, the PA28 (SSR 3A 0430) was 5nm NW of the C182 (SSR 3A 3650).

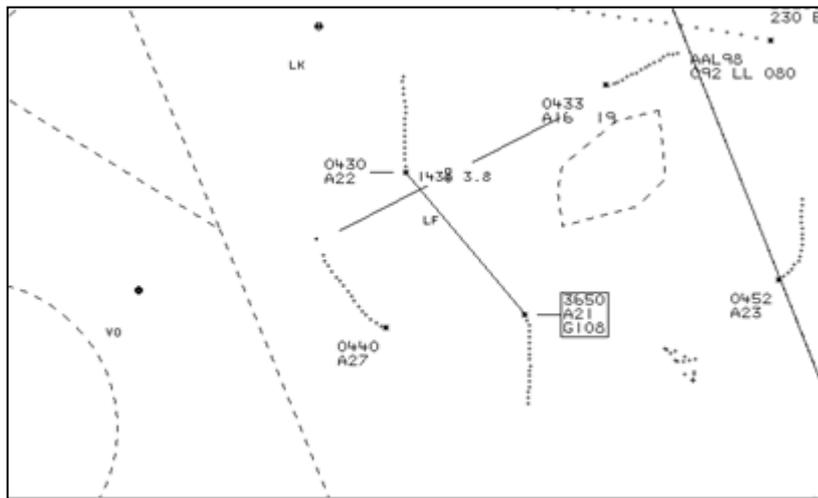
Figure 2: Incident Geometry at 1057:55.

Immediately after terminating the landline call to Farnborough APP, at 1057:55 RAD provided TI to the C182 flight on the PA28, advising, “*(C182 c/s) as you turn, traffic North, three miles, tracking south, similar height.*” Figure 2 depicts the incident geometry at this point, placing the PA28 3.8nm NW of the C182. The C182 pilot acknowledged the TI stating that they were “*good V-M-C, looking, nothing seen.*” At 1058:10, RAD provided updated TI on the PA28 to the C182 pilot, advising that the “*...previously reported traffic now North, 2 miles, tracking South, similar height*”, which was acknowledged. The position report element of the TI was again inaccurate, in that the PA28 was 3nm NW of the C182.

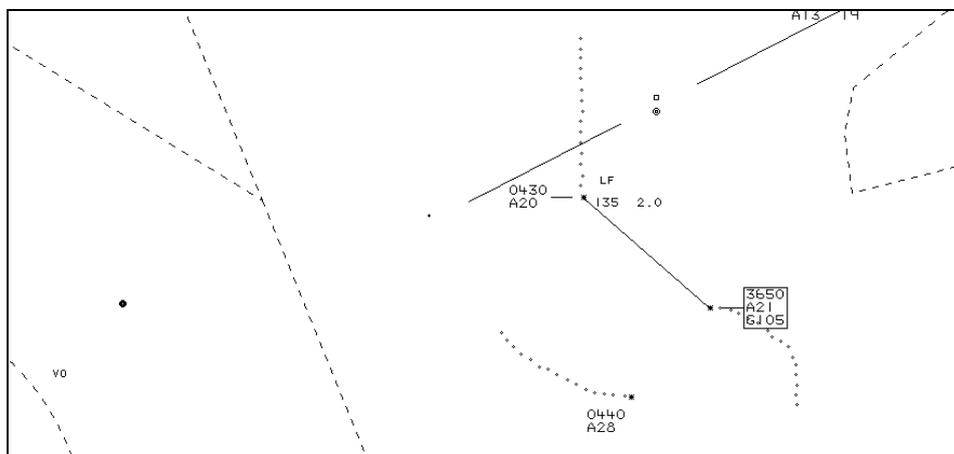
Figure 3: Incident Geometry at 1058:33.

At 1058:33, RAD provided a further update of the TI to the C182 flight, describing the PA28 as, “...now right one o’clock, one and a half miles, tracking South, similar height”, which was acknowledged; Figure 3 depicts the incident geometry at this point, placing the PA28 2nm NW of the C182.

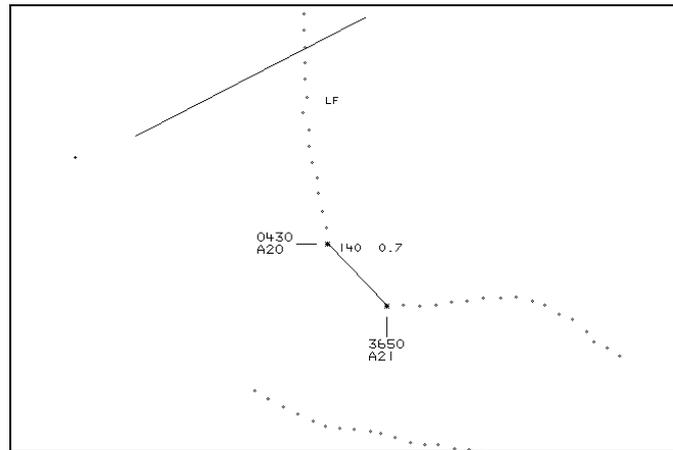
Figure 4: Incident Geometry at 1059:00.

RAD provided a further update to the TI at 1058:50, advising the C182 pilot that the PA28 was, “...now right one o’clock, half a mile (radar replay shows 1.1nm), crossing right to left, similar height.” Immediately after this transmission ended, the C182’s pilot advised Radar at 1059:00, “(C182 c/s) in fact, yep, got him now and err I’ll avoid”, which was acknowledged by RAD. At this point, the PA28 was 0.7nm NW of the C182, tracking SSE’ly, indicating 2000ft; the C182 was tracking W’ly established on the LOC, indicating 2100ft. Figure 4 depicts the incident geometry at this point. At 1059:04, the C182 pilot advised Radar that the PA28 was, “...just passing us to the right, he’s going

behind, well clear.” The radar replay shows that at this point the PA28 was 0.3nm NW of the C182, maintaining a SSE’y track indicating 1900ft. The PA28 can then be observed making a hard turn to port at 1059:10, passing 0.2nm NE of the C182 and indicating 200ft below. This point represents the CPA, 5.6nm E of Odiham.
