AIRPROX REPORT No 2013018

Date/Time: 6 Apr 2013 1728Z (Saturday)

Position: 5115N 00049W
(3nm SW of Farnborough
- elev 238ft)

Airspace: Farnborough ATZ(Class: G)

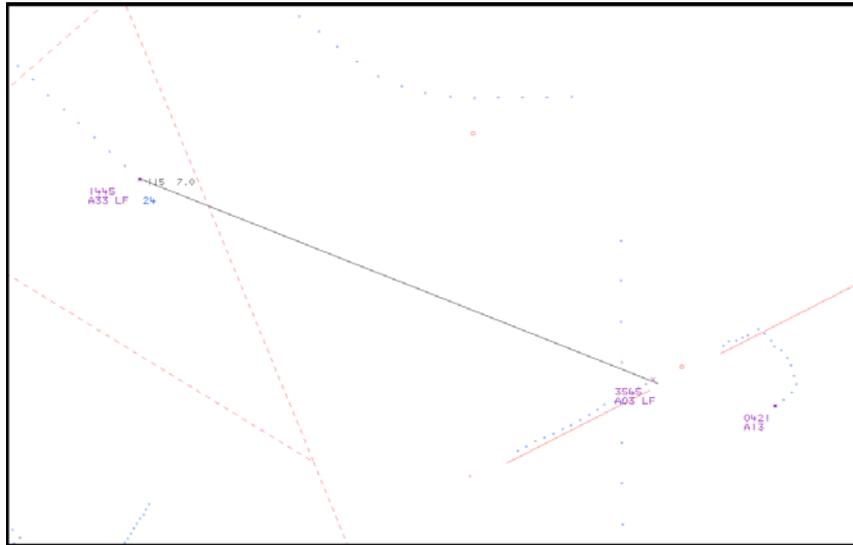
(Picture 1 – MRT at 1726:34)

At 1726:36, the PA28 pilot reported downwind and TWR responded, “(PA28)c/s *Roger report final.*” The CE560XL is shown 7nm W of the airfield squawking 1445 with the PA28 downwind RH (Picture 1).

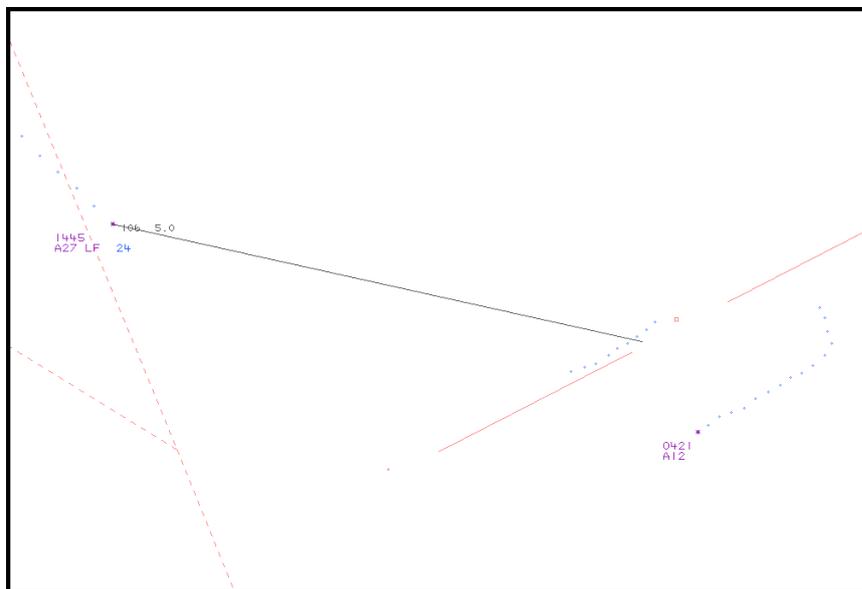
(Picture 2 – MRT at 1727:13)

At 1727:13, APP asked the CE560XL pilot if he was happy to continue for the visual approach with the balloon in sight. The pilot replied, “*Continue approach with the balloon in sight.*” APP responded, “*And (CE560XL)c/s you are cleared the visual approach further descent in accordance with the standard noise abatement procedures to be established not less than three DME.*” This was acknowledged by the CE560XL pilot. The CE560XL was 5nm W of the airfield at 2700ft (Picture 2).

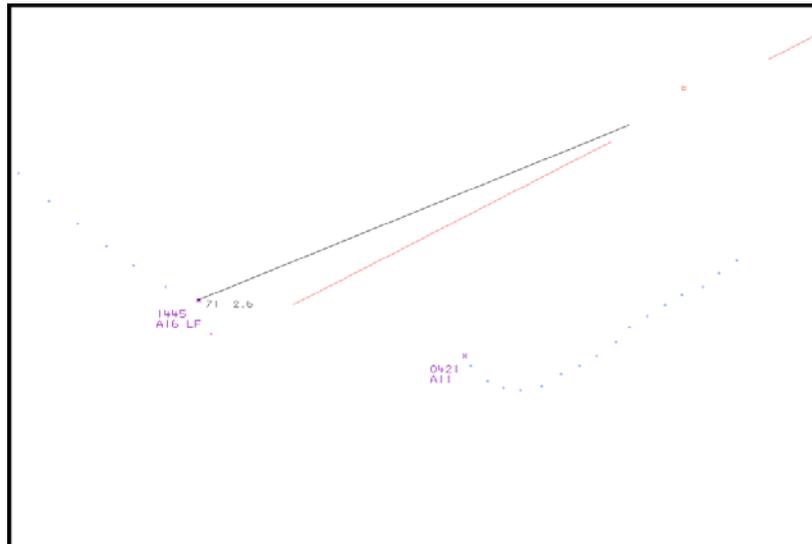
(Picture 3 – MRT at 1728:13)

At 1728:13, APP showed the PA28 had turned onto base leg and the CE560XL was beginning to commence a L turn towards final approach (Picture 3).

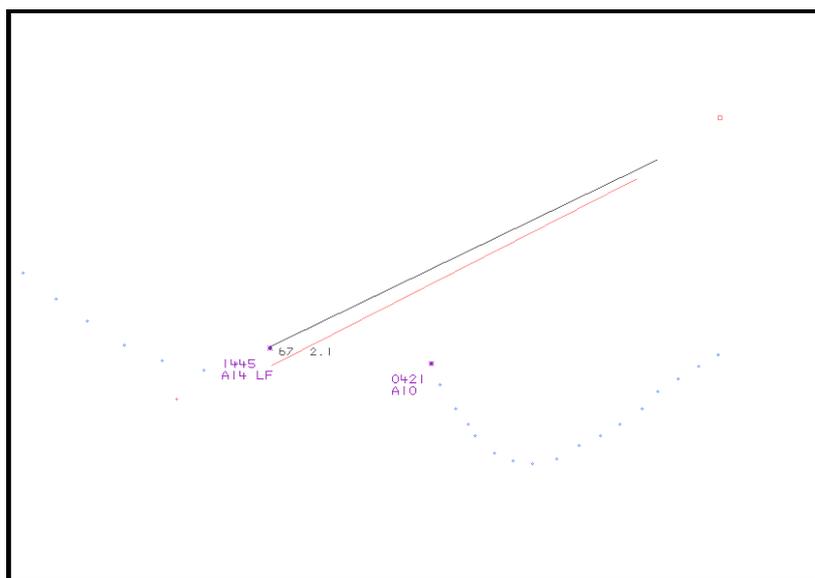
(Picture 4 – MRT at 1728:23)

The CE560XL was indicating a groundspeed of 179 knots and the PA28 69 knots. TWR recognised that the CE560XL was turning towards final approach and at 1728:23, TWR telephoned APP (in an urgent tone), “...is the CE560XL coming in now” (Picture 4).

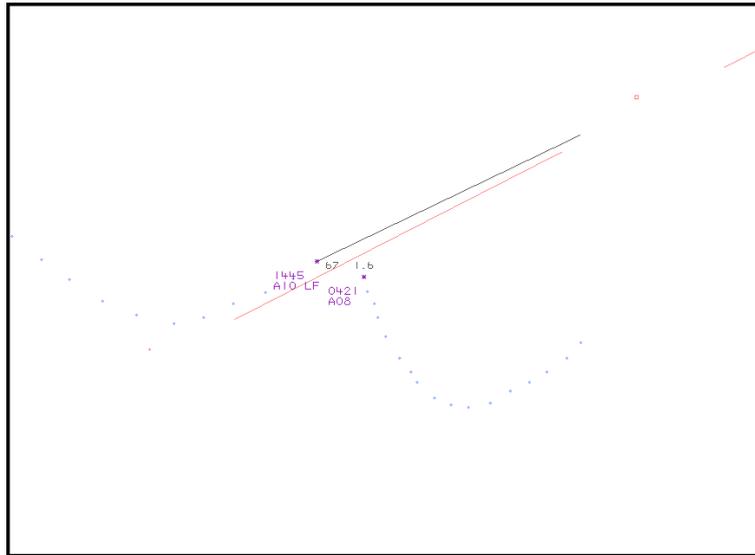
(Picture 5 – MRT at 1728:36)

APP responded, “Er should be with you sorry-Yes he’s visual” and TWR advised that the CE560XL had not called. Both controllers attempted to contact the CE560XL at 1728:36. The distance between the two ac was 0.3nm (Picture 5).

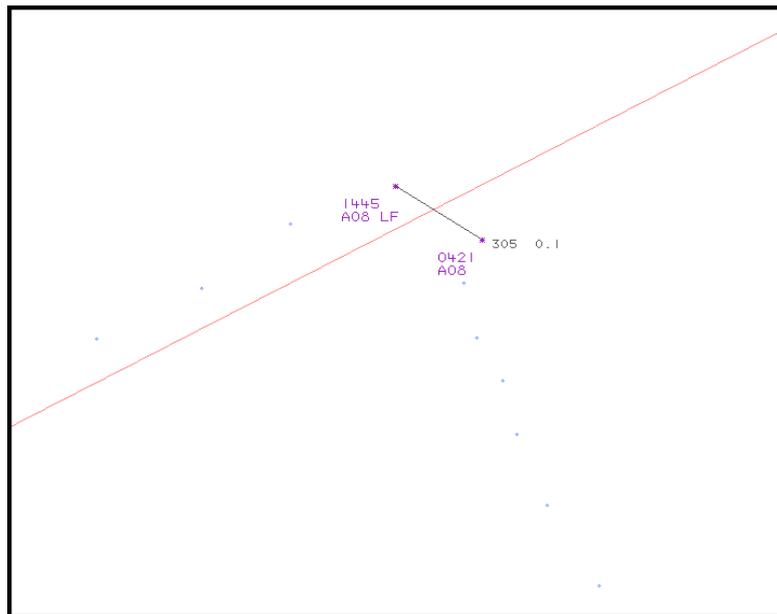
(Picture 6 – MRT at 1728:38)

At the end of the call (1728:38) the OJTI instructed TWR to break off the PA28. TWR responded, “*He’s breaking off.*” The PA28 was shown commencing a R turn (CPA) with a minimum separation of 0.1nm at the same level (Picture 6).

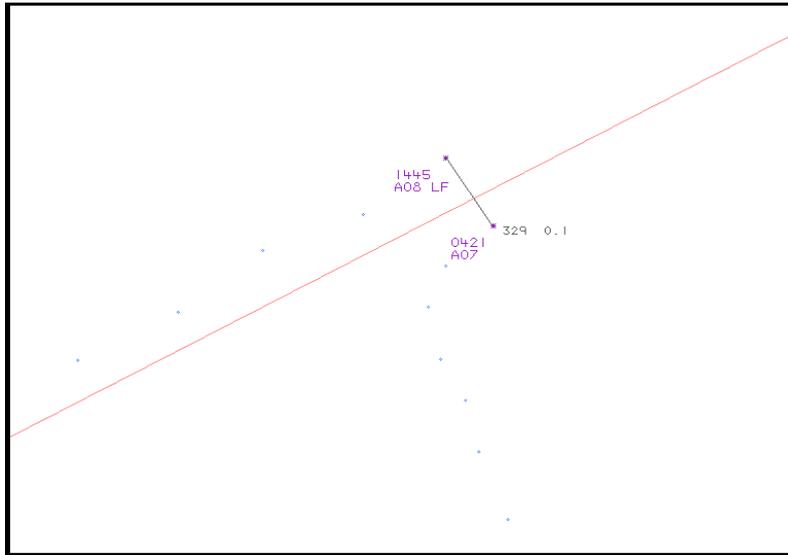
(Picture 7 – MRT at 1728:42)

At 1728:42, the CE560XL pilot called, “(CE560XL) *Farnborough Tower*” and the PA28 called, “(PA28)c/s *is avoiding.*” Radar showed two ac on parallel tracks with a minimum horizontal distance of 0.1nm (Picture 7).
