## AIRPROX REPORT No 2013037

Date/Time: 16 May 2013 1550Z

Position: 5358N 00014W  
(9nm NE of Leconfield)

Type: Jetstream JS41 F15E

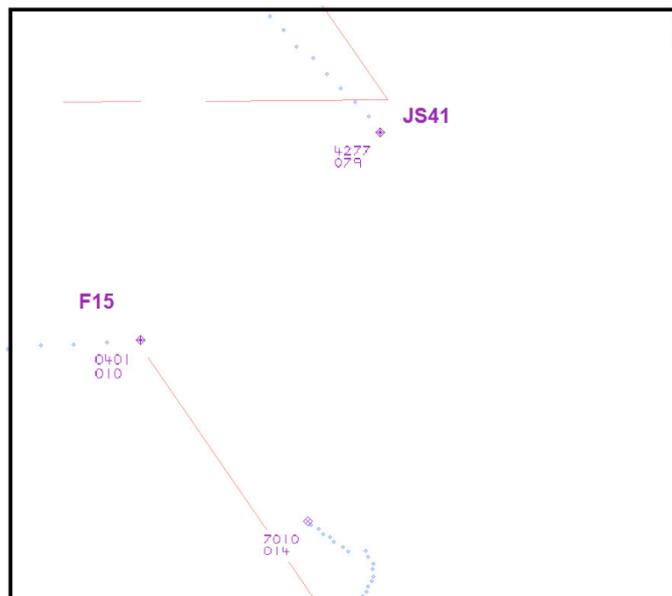
Figure 1 – Claxby & Manchester MRT at 1549:43

The JS41 was in receipt of a DS from LATCC(Mil) NE and at 1549:43, the controller, having placed the JS41 on a radar heading, contacted Humberside Radar with a radar handover. Radar showed the JS41 squawking 4277 at FL79 (Figure 1) as well as two other ac, one squawking 7010, indicating FL014, and the second, the F15, squawking 0401 indicating FL010 (an altitude of 676ft using the Humberside QNH 1001 hPa, with 1hPa equivalent to 27ft). The F15 was 4.6nm SW of the JS41.

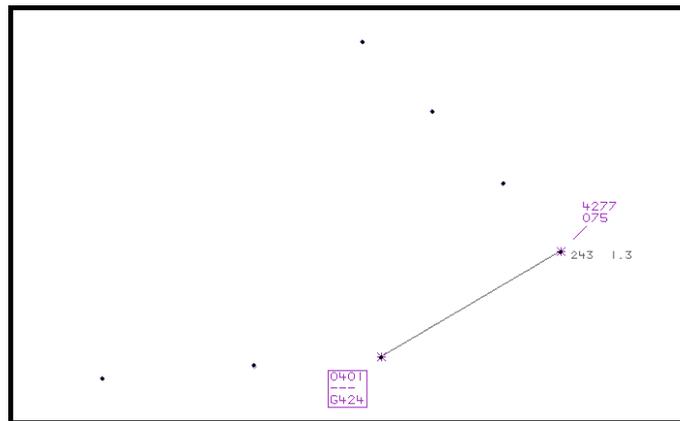
Figure 2 – Claxby single source at 1550:20

controller reported that the JS41 was bearing 350° from OTR at 15nm heading 140° and squawking 4277. The Humberside Radar controller responded, “Contact” and the LATCC(Mil) NE controller continued, “Descending flight level seven zero deconfliction service just turned him right ten degrees to get a gap on the seven zero one zero squawk erm but we’re happy to come to Otringham now if you are.” Humberside Radar replied, “Er no (JS41)c/s is identified continue that heading contact Humberside radar one one nine decimal one two five.” The Humberside Radar controller’s written report indicated that, from the relative speeds of the ac, he judged the 0401 squawk would pass in front of the JS41 and considered that a turn towards OTR would place the JS41 overhead the 0401 squawk. There was no discussion during the handover regarding the unknown 0401 squawk. The call was terminated at 1550:14 and at this point radar showed the two ac (JS41 and F15) converging at a range of 1.7nm. At 1550:20 the range had reduced to 1.3nm and the Mode C of the F15 was no longer shown on the Claxby radar (FL012 on MRT). The groundspeed of the F15 was 424kt (Figure 2).

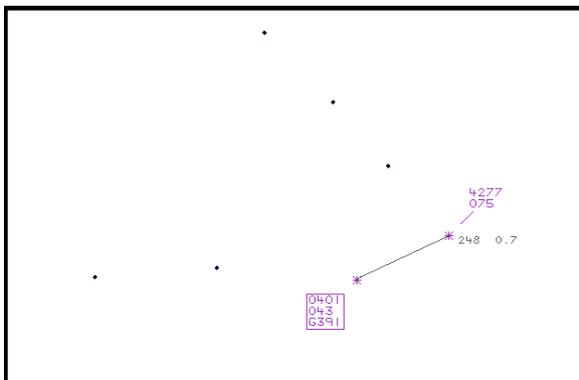
Figure 3 – Claxby single source at 1550:28

The next two successive sweeps of the Claxby radar, at 1550:28 and 1550:36, showed the F15 Mode C indicating FL043 and then FL055. (Figure 3 and Figure 4).

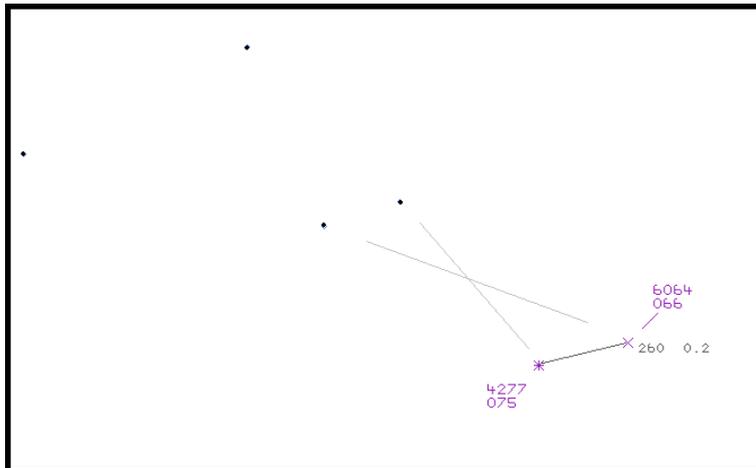
Figure 5 – Claxby single source 1550:44

At 1550:32, the F15 pilot was instructed to squawk 6064 by LATCC(Mil) E and the new SSR code was displayed on the next sweep of the radar at 1550:44. The Claxby radar showed that the tracks had crossed with the JS41 at FL075 and the F15 at FL066 (Figure 5).

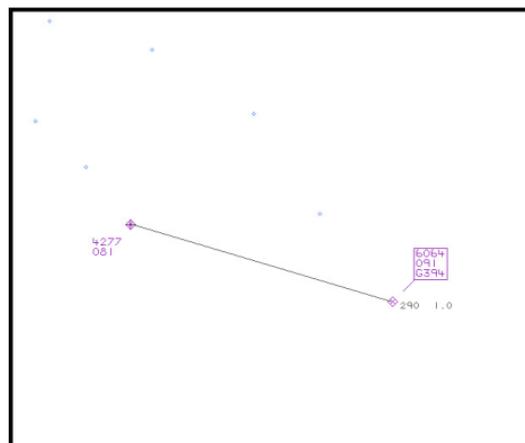
Figure 6 – Claxby & Manchester MRT at 1551:06

The JS41 pilot’s report indicated intermittent IMC at FL75 and the F15 pilot’s report indicated VMC with flight visibility 20km. At no time was the F15 pilot visual with the other ac. The two ac continued to diverge and at 1551:06, the F15 was 1000ft above the JS41 (Figure 6).

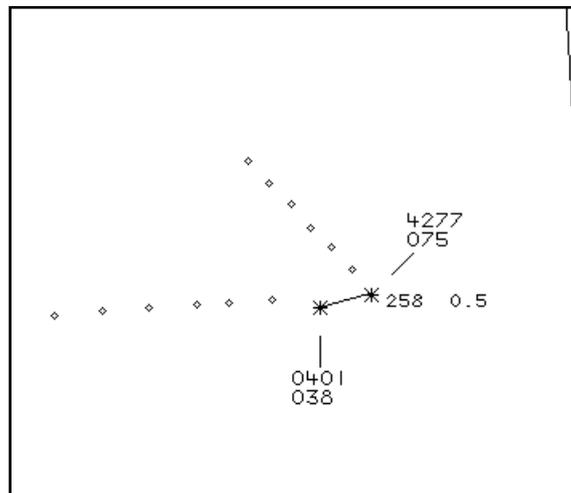
Figure 7: Incident Geometry at 1550:30

At 1550:23, the F15 crew free-called LATCC(Mil) E Tac, passing their callsign and were instructed by LATCC(Mil) E Tac to, "squawk 6-0-6-4, pass message." The F15 crew read back the squawk at 1550:30 and stated that they were, "requesting to route Flight Level one hundred, traffic service... [garbled but believed to be en-route to a point of destination]." As the F15 crew read back the SSR mode 3/A code, the Mode C data became visible on the radar replay, indicating a climb through 3800ft, 0.5nm WSW of the JS41; Figure 7 depicts the incident geometry at this point.

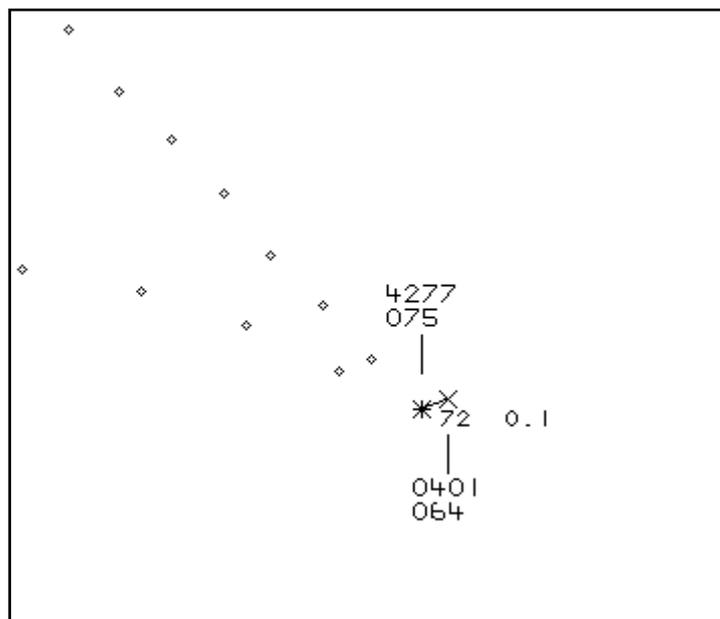
Figure 8: Incident Geometry at 1550:42

The CPA occurred between sweeps of the radar at 1550:40 with no recordable lateral separation. The sweep before the CPA (:38) depicts the F15 climbing through FL58 and the sweep after (:42) depicts it climbing through FL64; the JS41 indicated FL75 throughout the incident. Figure 8 depicts the incident geometry at 1550:42. The SSR mode 3/A code assigned by E Tac to the F15 was not visible on the radar replay until 1550:50.
