AIRPROX REPORT No 2013050

Date/Time: 7 Jun 2013 0953Z

Position: 5310N 00031W
(RAF Waddington Visual Cct
- elevation 231ft)

Airspace: RAF Waddington ATZ (Class: G)

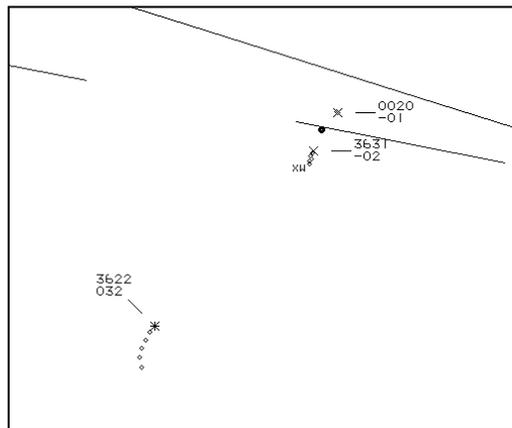
Figure 2: Incident Geometry at 0951:13.

The incident sequence commenced at 0951:13 as the BE200 pilot called ADC to “request join” and was instructed to “join runway 0-2 right hand, Q-F-E 1-0-1-7, one in, one shortly to depart.” The BE200 crew did not acknowledge or readback the joining clearance and airfield details. At this point the BE200 was 6nm SW of WAD, indicating descent through 3200ft, tracking 036°; the BN2 was at the hold, not yet airborne. Figure 2 depicts the incident geometry at this point; SSR 3A 3631 and 0020 were the unrelated ac being provided with an ATS by WAD ADC. The IP for WAD RW02RH is 4nm S and 1nm W of the RWY centre-line; at 0951:13, the BE200 was positioned 2.2nm W of the RWY centre-line.

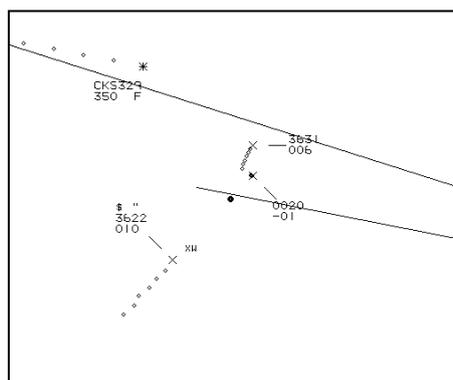
Figure 3: Incident Geometry at 0952:38.

At 0952:38, the ADC asked the BE200 crew “are you visual with the one [BN2] departing?” who replied that they were. Figure 3 depicts the incident geometry, with the BE200 1.5nm SW of WAD and the BN2 not yet airborne. At this point, the BE200 had closed to 0.7nm W of the extended RWY centreline and was tracking 045°.

From 0952:54, some track jitter is evident on the radar replay; however, it appears that the BE200 had manoeuvred W'ly to open their distance from the extended centreline. At 0953:01, the BE200 crew advised ADC that they were “extending upwind to slightly avoid the downwind traffic [SSR 3A 3631 in Figure 3]” which was acknowledged by the ADC at 0953:07, asking them to “confirm you are visual with the traffic [BN2] in your left 11 o'clock?” The BE200 crew replied “Affirm [BE200 C/S] we got airborne with the traffic [BN2] behind us departing, is this the one you mean?” The ADC replied in the affirmative. At 0953:09, the BE200 passed 0.3nm W of the RWY, tracking 037°. The BN2's crew related in their DASOR that they were aware of this R/T exchange between the ADC and the BE200 pilot; however, they were unaware that it related to them as the ADC had specified “one departing” rather than ‘a BN2 departing’.

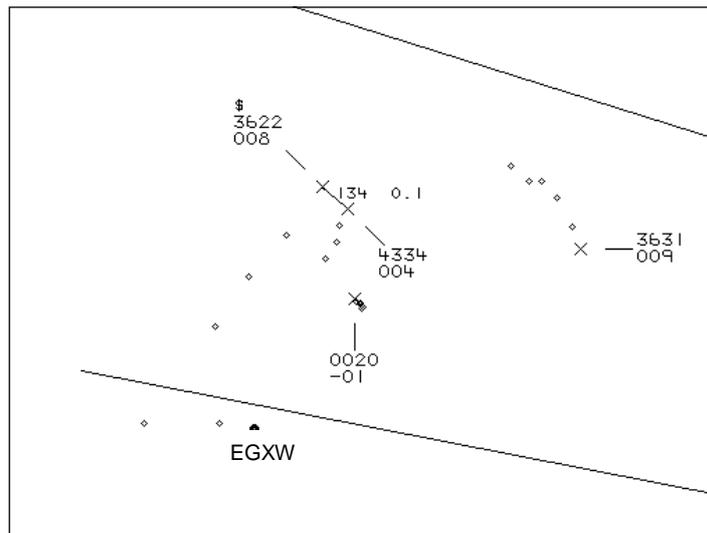
Figure 4: Incident Geometry at 0953:22.

The CPA occurred at 0953:20 as the BE200 passed 0.1nm down the BN2's L side, indicating 400ft above; Figure 4 depicts the incident geometry. At 0953:26, the BE200 passed 0.2nm through the BN2's 12 o'clock, breaking downwind at 0953:50, 0.8nm NE of the BN2 and co-altitude with it.
