## **AIRPROX REPORT No 2013056**

Date/Time: 27 Jun 2013 0800Z

Position: 5027N 00502W  
(2nm NW Newquay Airport)

Airspace: Newquay Airport ATZ(Class: G)

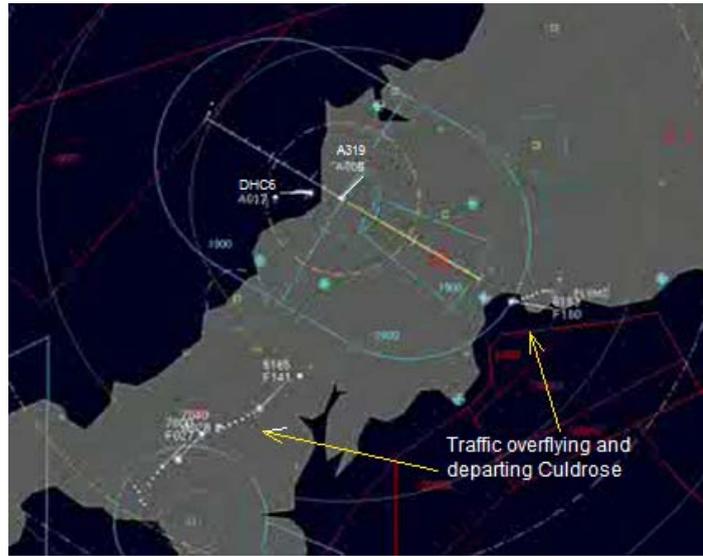
Figure 1 - Newquay Radar at 0800:26

At 0800:26 the Tower controller notified Approach that the A319 was airborne on the hour. The A319 then appeared on radar passing 500ft with the DHC6 in the A319's 11 o'clock at a range of 1.8nm, indicating 1700ft as shown in Figure 1.

The DHC6 had not completed the right turn and was still converging with the extended centreline. The Approach controller notified the Tower that the DHC6 was now positioning for an ILS approach. At this point the Mode C of the A319 faded from radar.

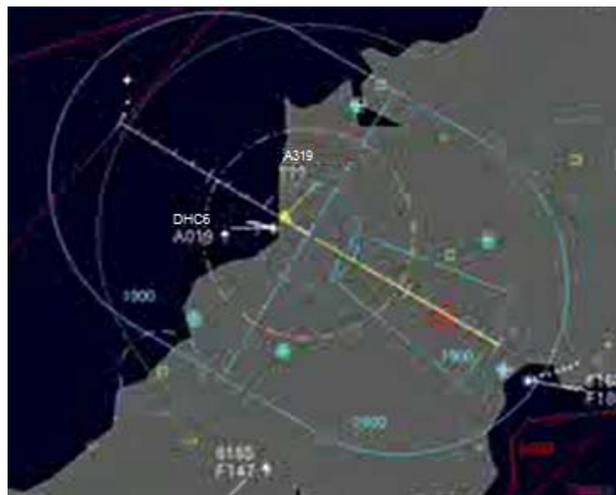
Figure 2 - Newquay Radar at 0800:42

At 0800:42 the two aircraft passed abeam at a range of 0.5nm, with the DHC6 passing 1900ft. There was no radar Mode C readout for the A319 (Figure 2).
