AIRPROX REPORT No 2013090

Date/Time: 30 Jul 2013 1126Z

Position: 53 11N 000 06E
(11.2nm NE of RAF Coningsby)

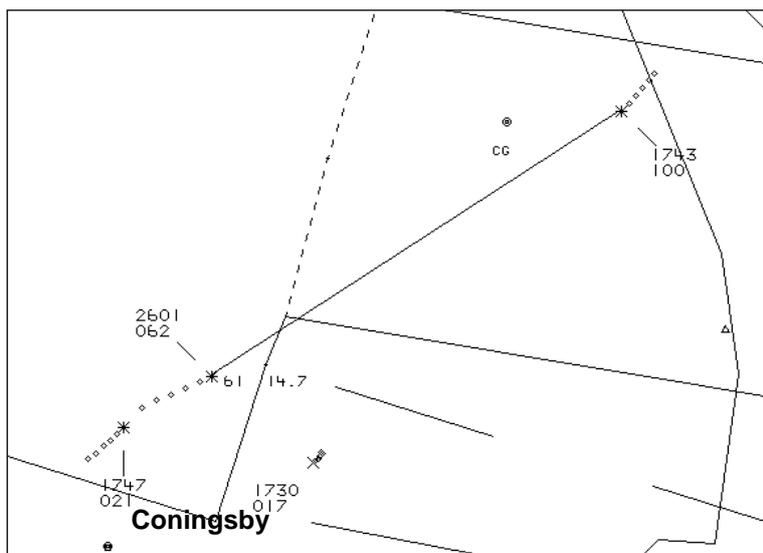
Figure 1: Incident Geometry at 1124:52.

During the Cranwell-Waddington handover at 1124:52, Cranwell Departures passed Traffic Information to the Hunter on the Typhoon, advising them *"traffic 12 o'clock, 1-2 miles, opposite direction, well above, descending, believed to be a recovery to Coningsby"* which was acknowledged. Figure 1 depicts the incident geometry at this point; SSR 3A 2601 is the Hunter (6.4nm north-north-east of Coningsby), SSR 3A 1743 is the incident Typhoon.

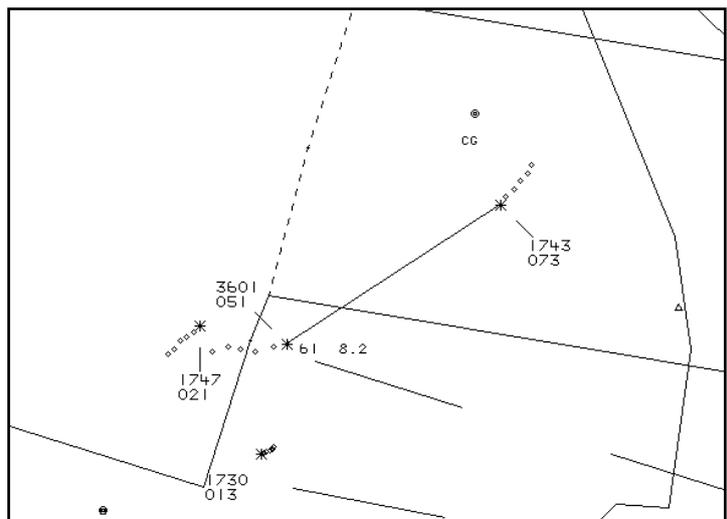
Figure 2: Incident Geometry at 1125:45.

As the handover of the Hunter from Cranwell to Waddington progressed, the SSR 3A assigned by Waddington to the Hunter became visible on the radar at 1125:42. Shortly after, at 1125:45, Cranwell Departures updated the Traffic Information on the incident Typhoon to the Hunter pilot, advising him “*previously reported traffic, north-east, 5 miles, south-westbound, above and descending*” which was acknowledged. Figure 2 depicts the incident geometry at this point; the Hunter’s SSR 3A was 3601.

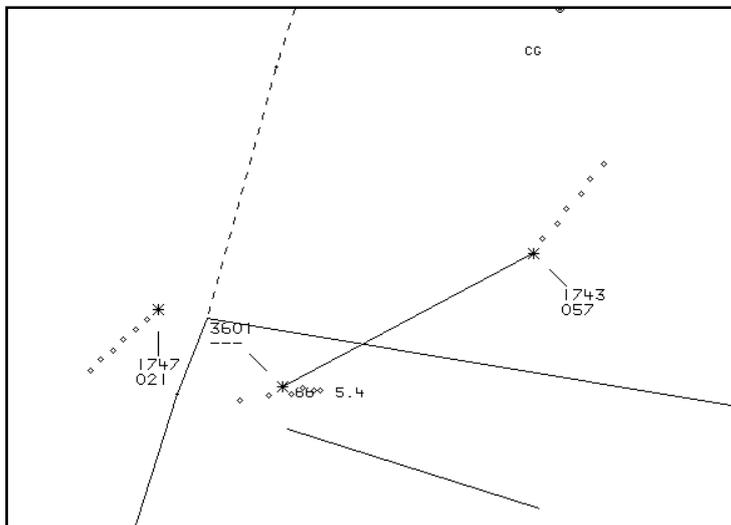
Figure 3: Incident Geometry at 1126:06.

At 1125:58, the Hunter commenced another period of dynamic manoeuvring with the aircraft’s SSR Mode C again becoming intermittent. Between 1126:07 and 1126:17, Coningsby Approach was involved in an exchange of RT with the next fast-jet recovering visually (32.3nm north-east of Coningsby, tracking south-westerly, indicating descent through FL131) whilst simultaneously advising Coningsby Tower of the incident Typhoon’s ‘fuel priority’ status. Co-incident with the start of this exchange, Cranwell Departures instructed the Hunter pilot to “contact Waddington Zone 1-2-7 decimal 3-5” which was acknowledged at 1126:09. Figure 3 depicts the incident geometry at this point, showing that the Hunter had adopted a westerly track.

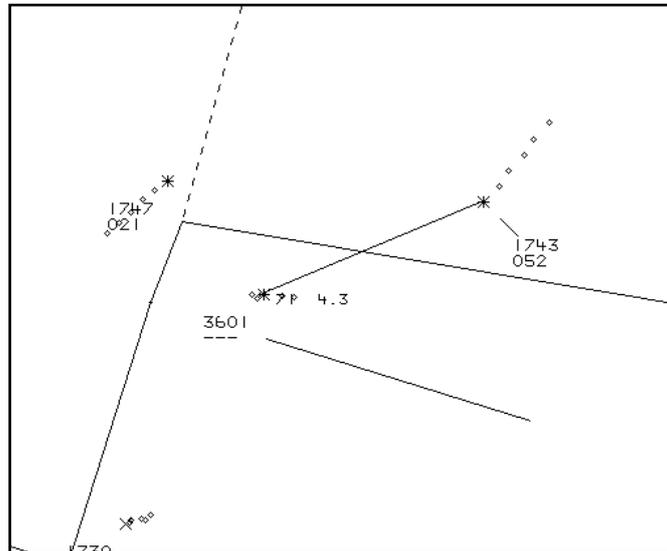
Figure 4: Incident Geometry at 1126:18.

At 1126:18, as Coningsby Approach advised Coningsby Tower that the incident Typhoon was 'fuel priority', the Hunter adopted an easterly track with no SSR Mode C information displayed. No other communication is recorded on the Coningsby Approach control position until after the CPA. Figure 4 depicts the incident geometry at this point

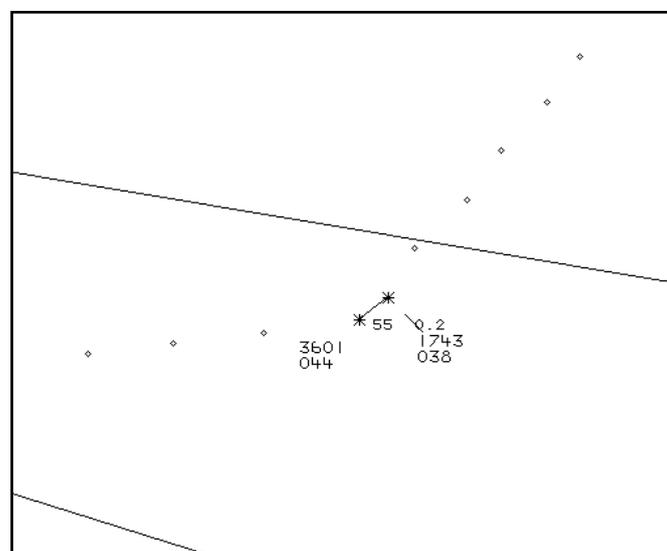
Figure 5: Incident Geometry at 1126:38.

At 1126:34, the Hunter's SSR Mode C becomes visible on the radar replay, 1nm south-west of the incident Typhoon, indicating FL44 with the aircraft maintaining its easterly track; the Typhoon was tracking south-westerly, indicating descent through FL44 with a rate-of-descent of approx 3000fpm. The incident Typhoon pilot reported 'regaining VMC below cloud at 4500ft' and sighting the Hunter around 4 secs later at a range of approx 1-1½nm. Assessing that the Hunter was on an 'apparent collision course', they initiated avoiding action by bunting from 5° to 20° nose down. The evidence of this bunt was clear on the next sweep of the radar at 1126:38, showing that the Typhoon's rate-of-descent had increased to approx 9000fpm; Figure 5 depicts the incident geometry at this point. The CPA occurred between sweeps of the radar at approx 1126:39, as the Hunter 'flew approx 500-600 ft above' the Typhoon. The Typhoon pilot then advised Coningsby Approach of the Airprox.
